STRUCTURAL-GENERAL NOTES

LIFE SAFETY REPAIR PLAN

SEBASTIAN RIVER HIGH SCHOOL
 Stadium Inspection
 9001 Shark Boulevard
 SEBASTIAN, FLORIDA

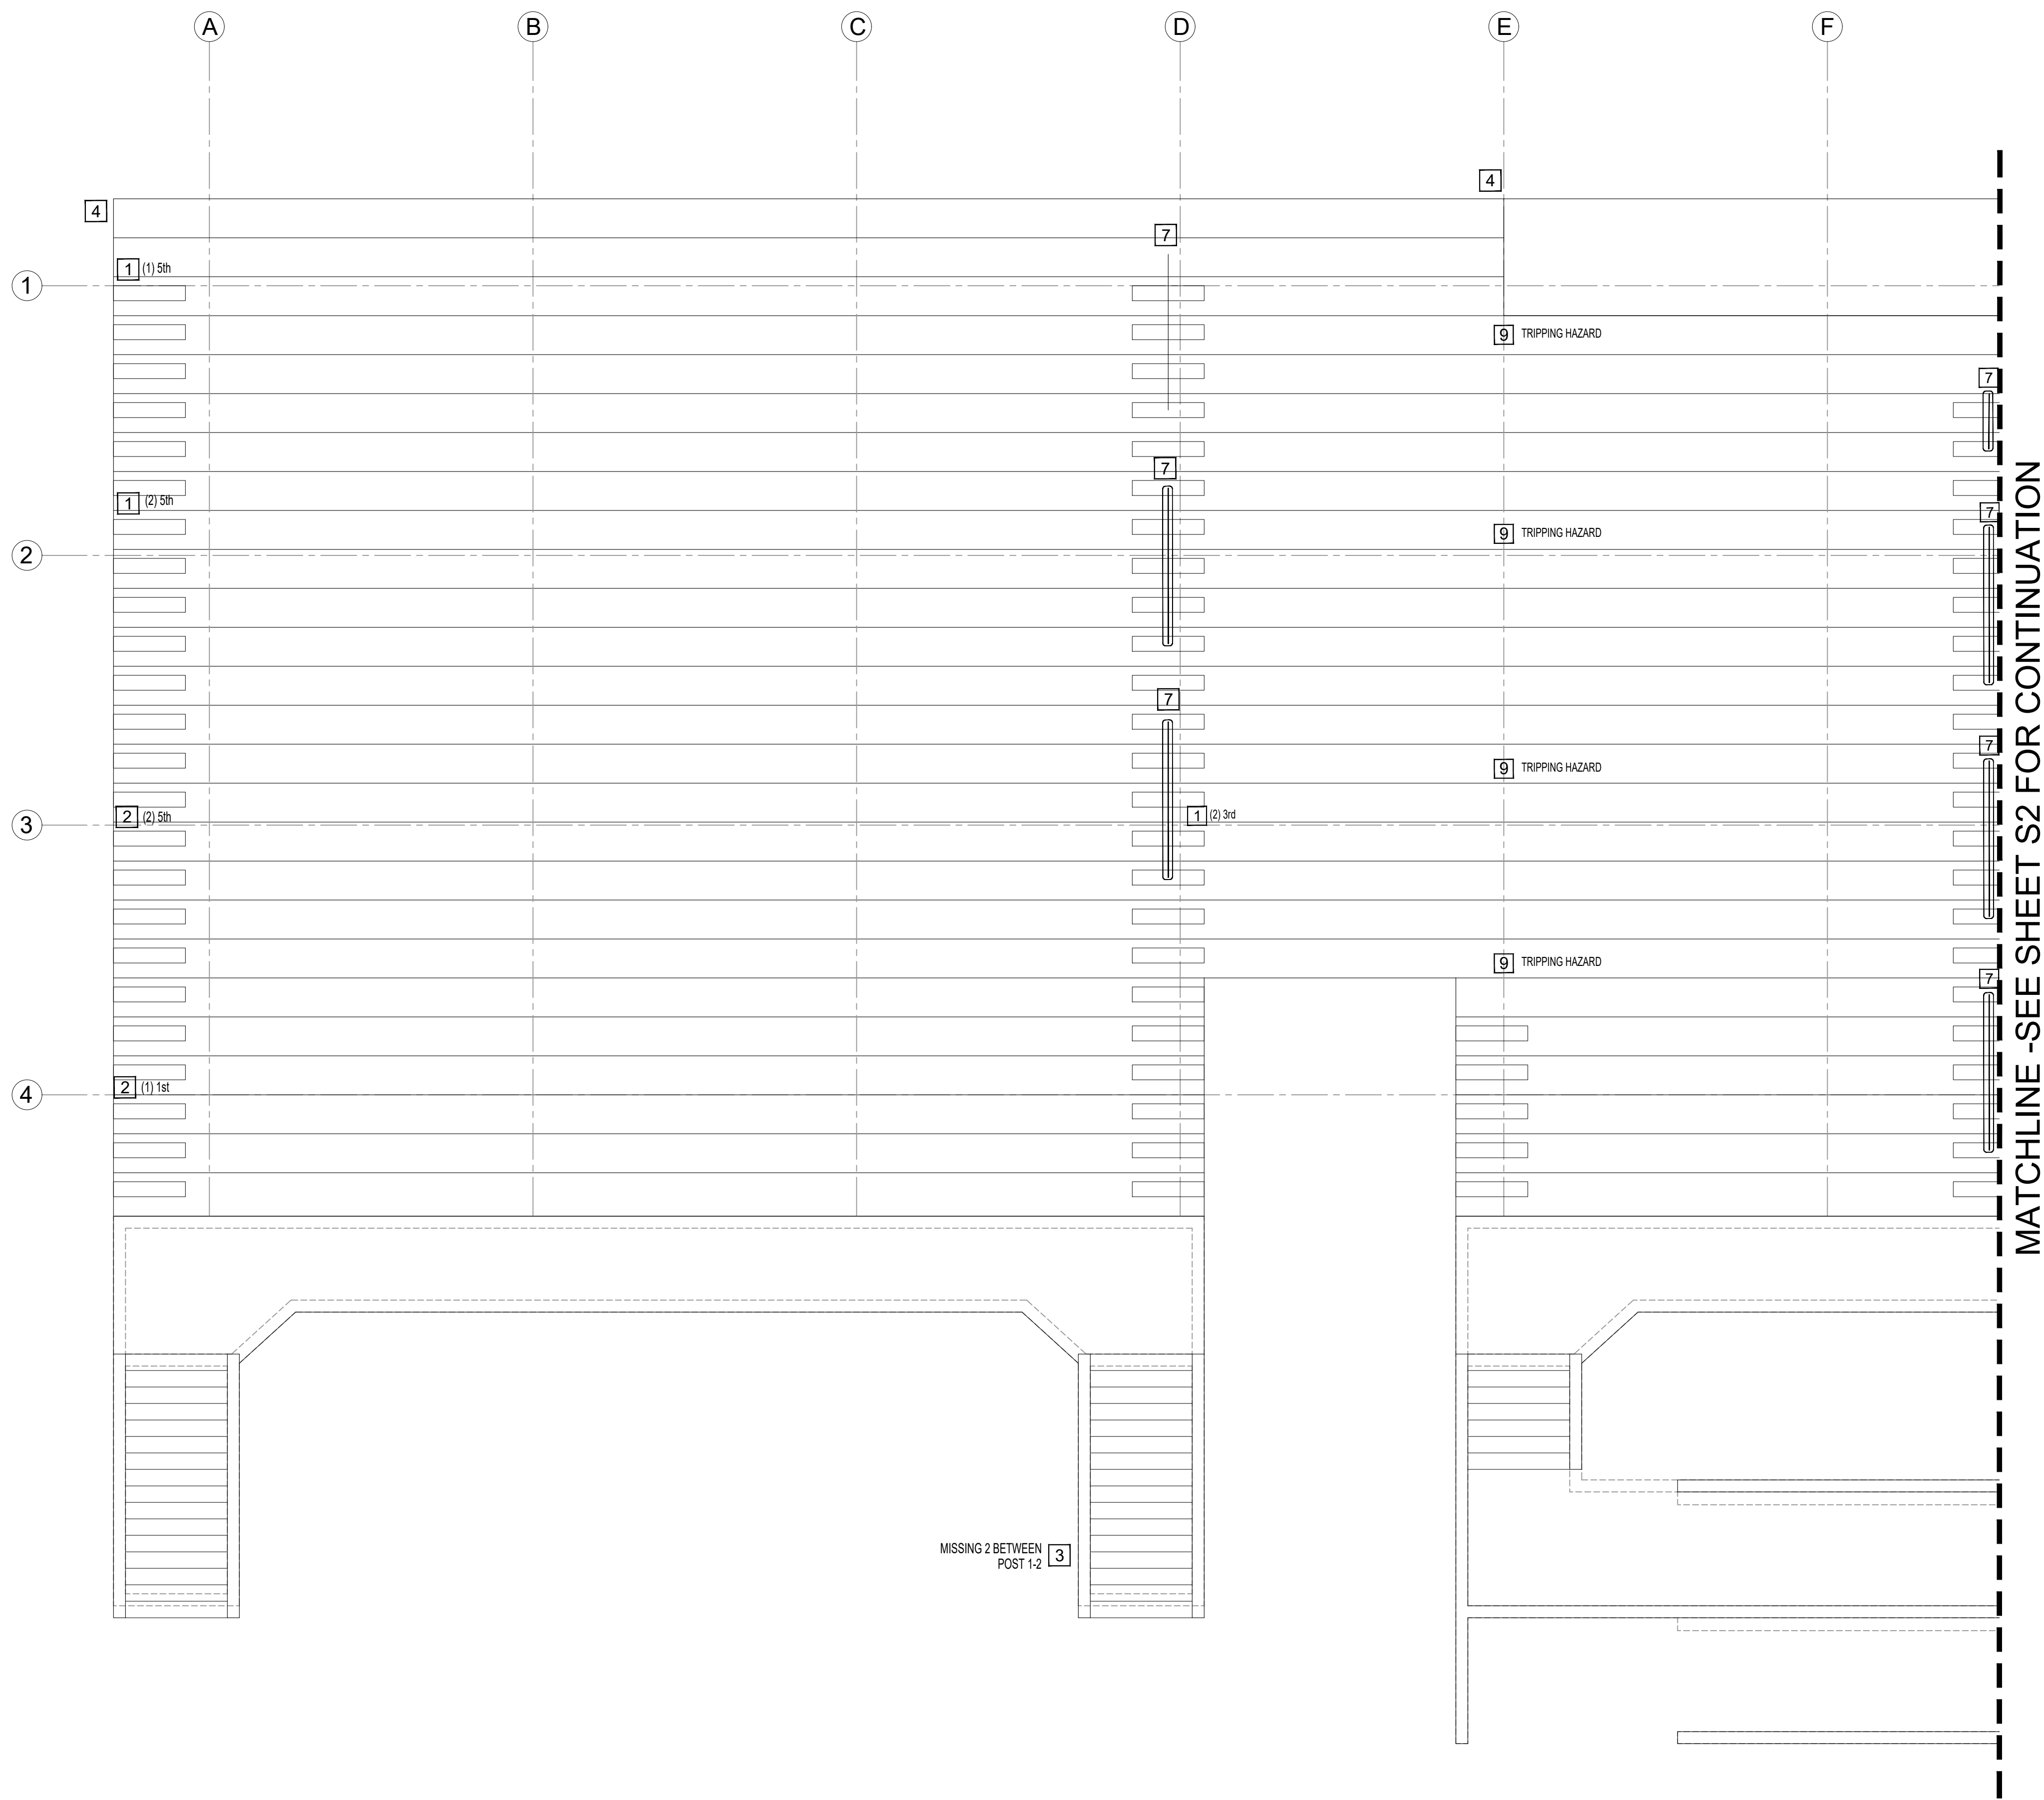
PLAN VIEW - HOME SIDE

1	REPAIR BRACKET TO SEAT CONNECTION (EA)	5	EA
2	REPAIR BOTTOM TO CONCRETE CONNECTION (EA)	3	EA
3	REPLACE CHAIN LINK CLIPS (EA)	2	EA
4	FENCE CHAIN LINK EXTENSION (ADDDREPAIR) (L.F.)	4	L.F.
5	REMOVE & REPLACE FENCE (L.F.)	-	L.F.
6	REMOVE & REPLACE GUARDRAIL (L.F.)	-	L.F.
7	REMOVE & REPLACE HANDRAIL (L.F.)	55	L.F.
8	REPLACE MISSING SEAT SEAM FASTENERS (EA)	-	EA
9	REMOVE ABANDONED POST (EA)	4	EA

(#) #
 INDICATES THE LOCATIONS OF CONNECTION FROM LEFT TO RIGHT
 INDICATES THE NUMBER OF CONNECTORS MISSING

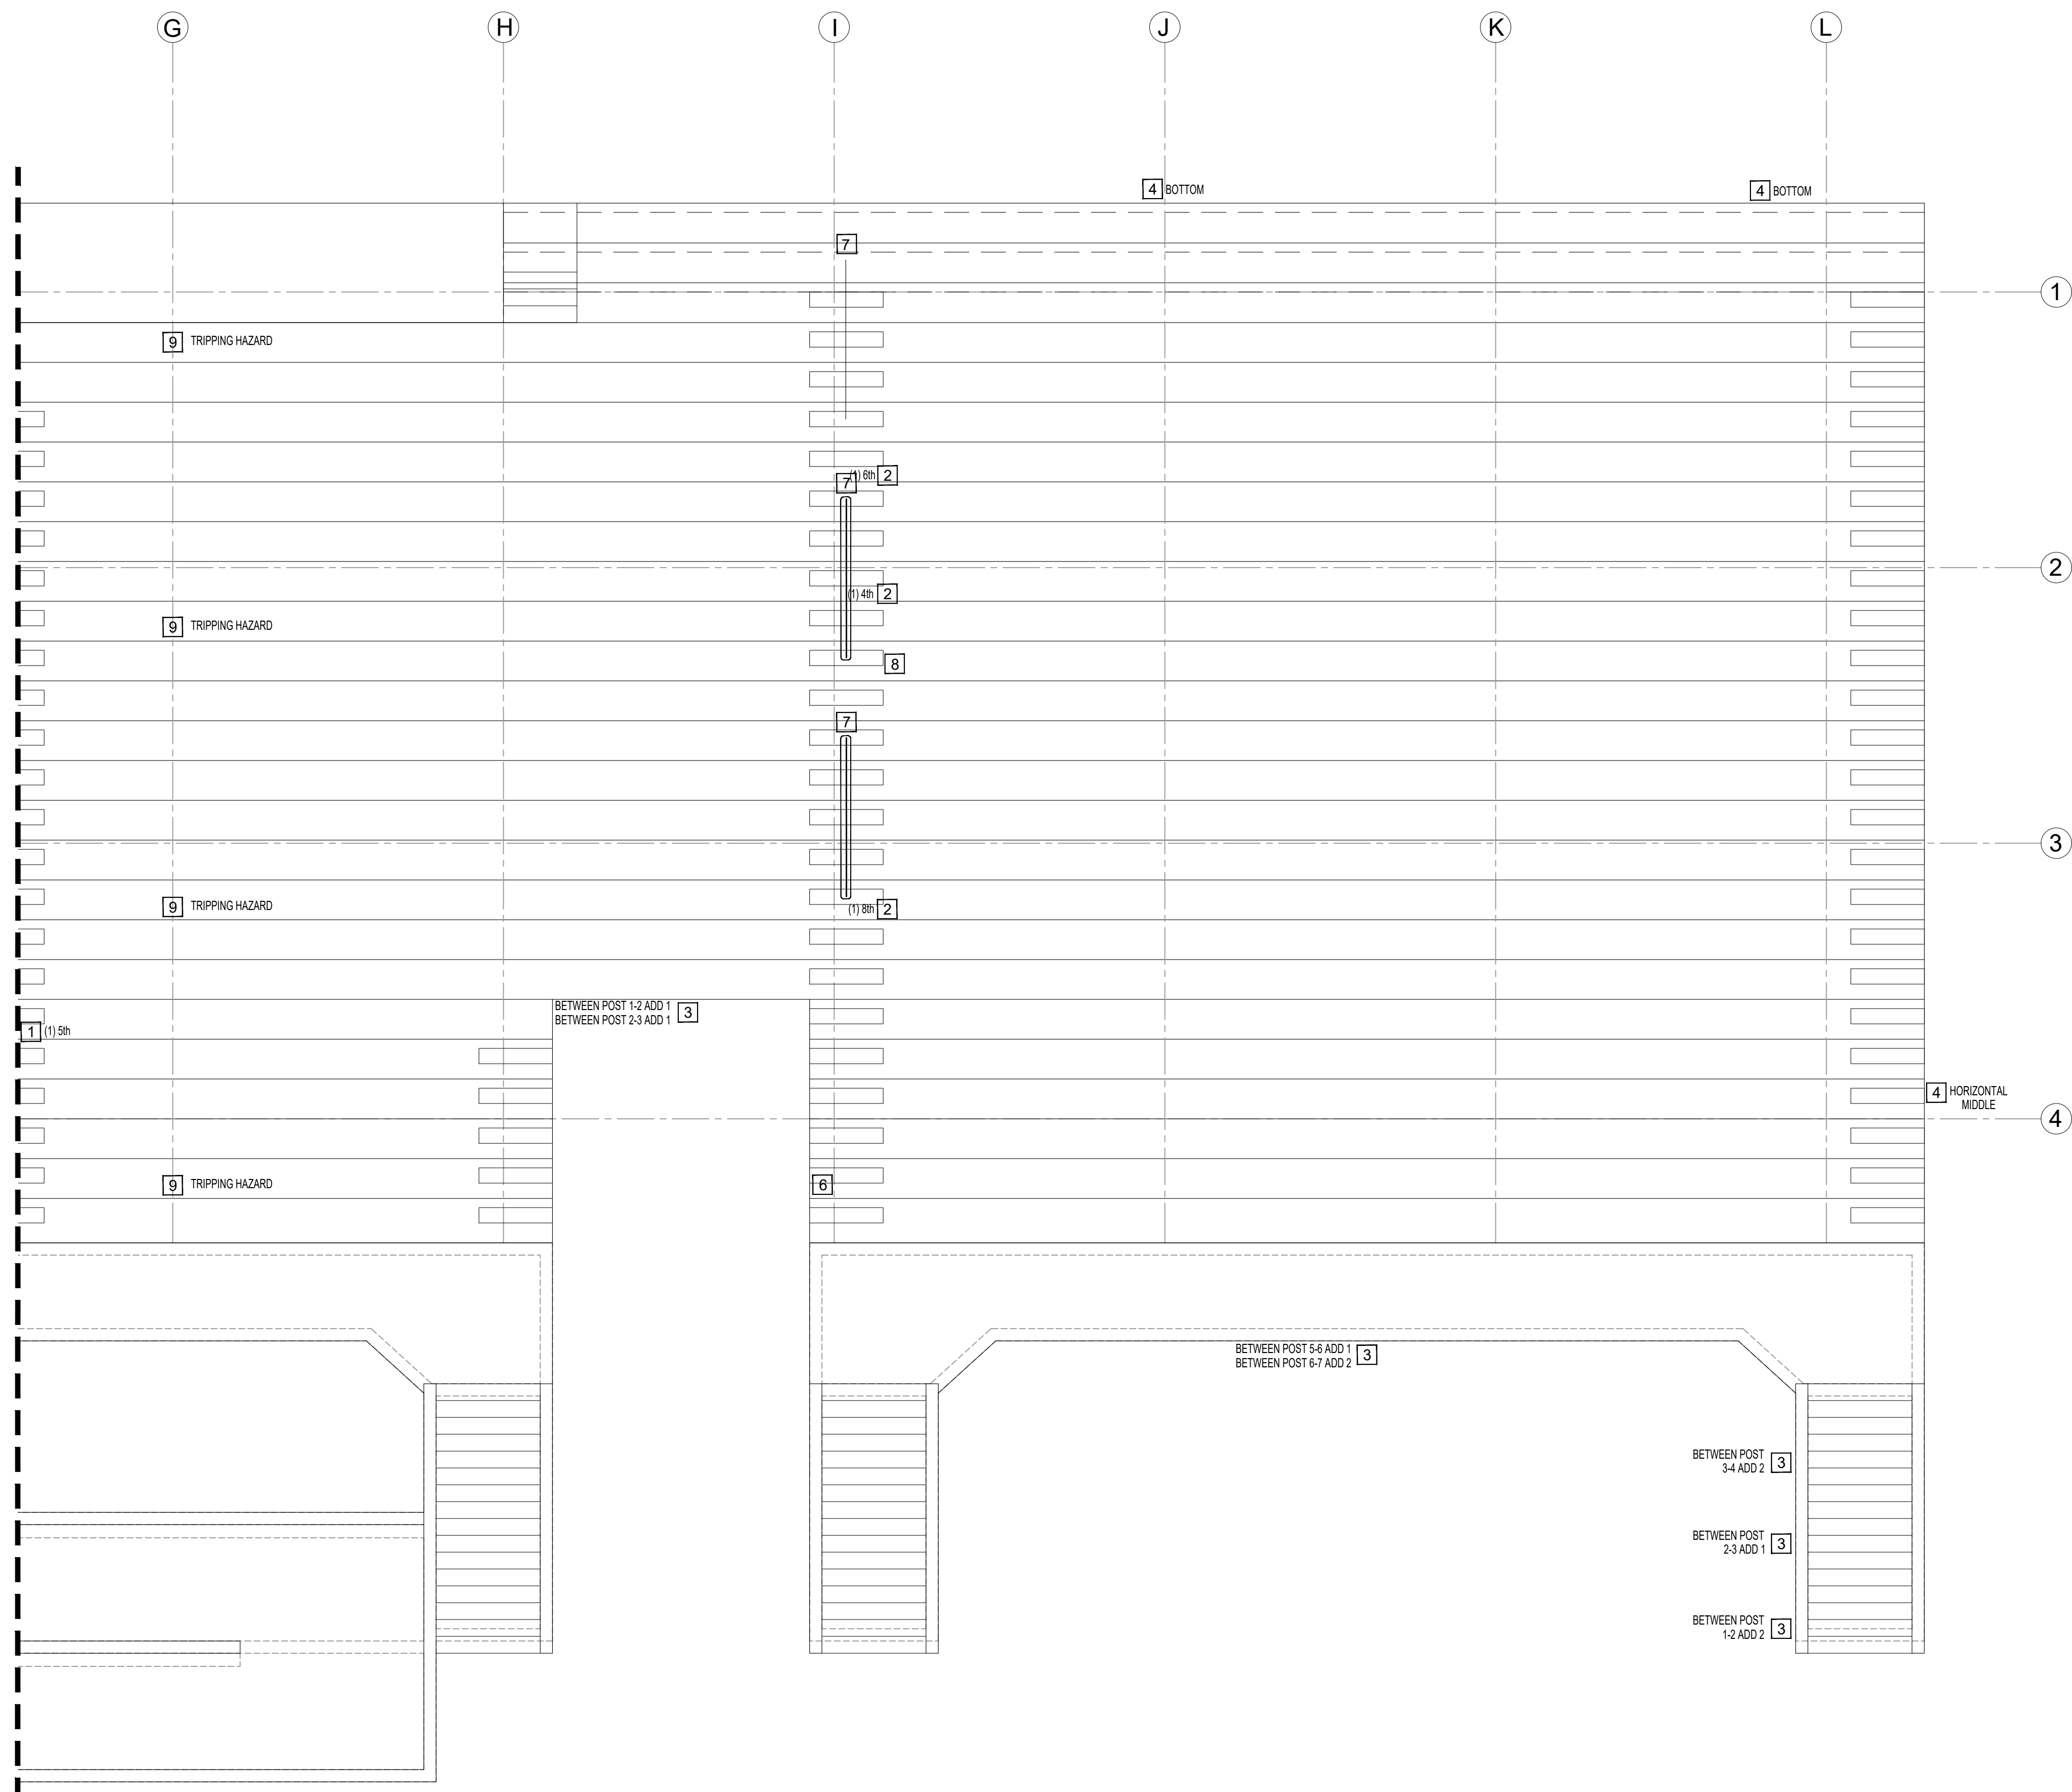
PLAN VIEW - HOME SIDE

LIFE SAFETY REPAIRS LEGEND			
1	REPAIR BRACKET TO SEAT CONNECTION (EA)	1	EA
2	REPAIR BOTTOM TO CONCRETE CONNECTION (EA)	3	EA
3	REPLACE CHAIN LINK CLIPS (EA)	10	EA
4	FENCE CHAIN LINK EXTENSION (ADD/REPAIR) (L.F.)	7	L.F.
5	REMOVE & REPLACE FENCE (L.F.)	-	L.F.
6	REMOVE & REPLACE GUARDRAIL (L.F.)	10	L.F.
7	REMOVE & REPLACE HANDRAIL (L.F.)	27	L.F.
8	REPLACE MISSING SEAT SEAM FASTENERS (EA)	1	EA
9	REMOVE POST (EA)	4	EA

(#) #
 ↑ INDICATES THE LOCATIONS OF CONNECTION FROM LEFT TO RIGHT
 ↓ INDICATES THE NUMBER OF CONNECTORS MISSING

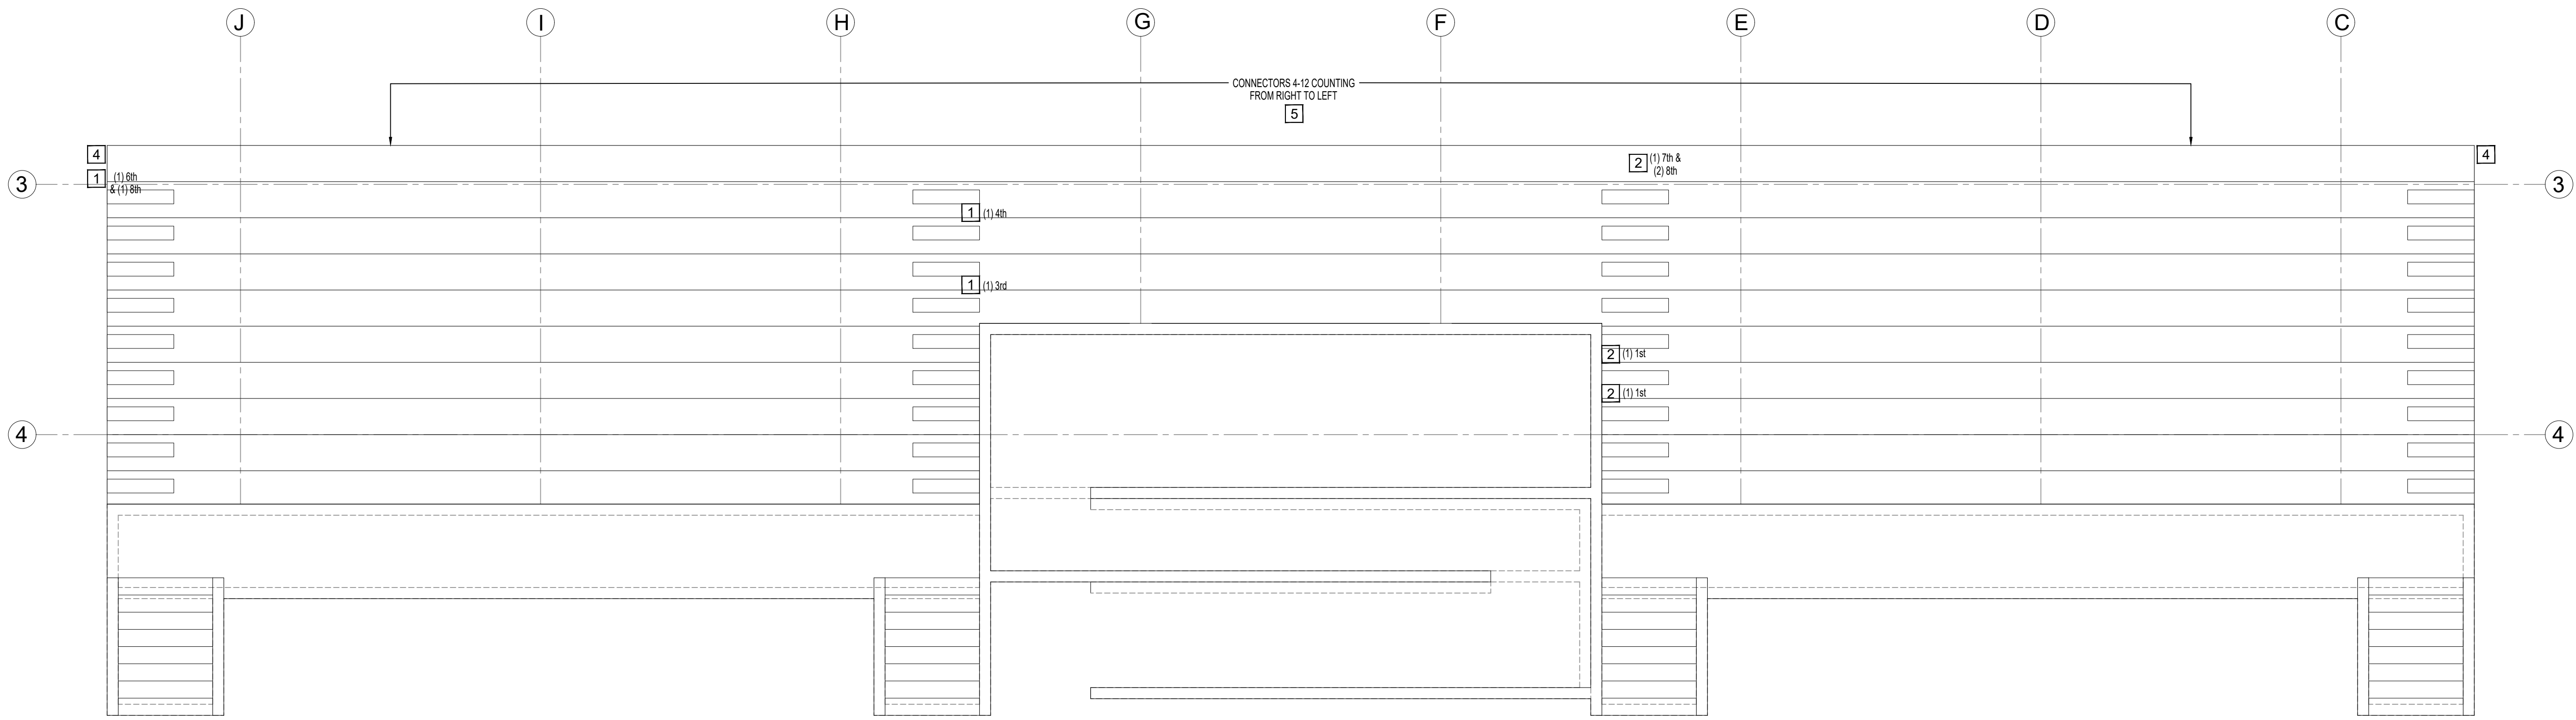
PLAN VIEW - VISITOR SIDE
SCALE: 3/16" = 1'-0"

LIFE SAFETY REPAIRS LEGEND		
1	REPAIR BRACKET TO SEAT CONNECTION (EA)	4 EA.
2	REPAIR BOTTOM TO CONCRETE CONNECTION (EA)	5 EA.
3	REPLACE CHAIN LINK CLIPS (EA)	- EA.
4	FENCE CHAIN LINK EXTENSION (ADD/REPAIR) (L.F.)	4 L.F.
5	REMOVE & REPLACE FENCE (L.F.)	109 L.F.
6	REMOVE & REPLACE GUARDRAIL (L.F.)	- L.F.
7	REMOVE & REPLACE HANDRAIL (L.F.)	- L.F.
8	REPLACE MISSING SEAT SEAM FASTENERS (EA)	- EA.
9	REMOVE POST (EA)	- EA.

(#) #
 INDICATES THE LOCATIONS OF CONNECTION FROM LEFT TO RIGHT
 INDICATES THE NUMBER OF CONNECTORS MISSING

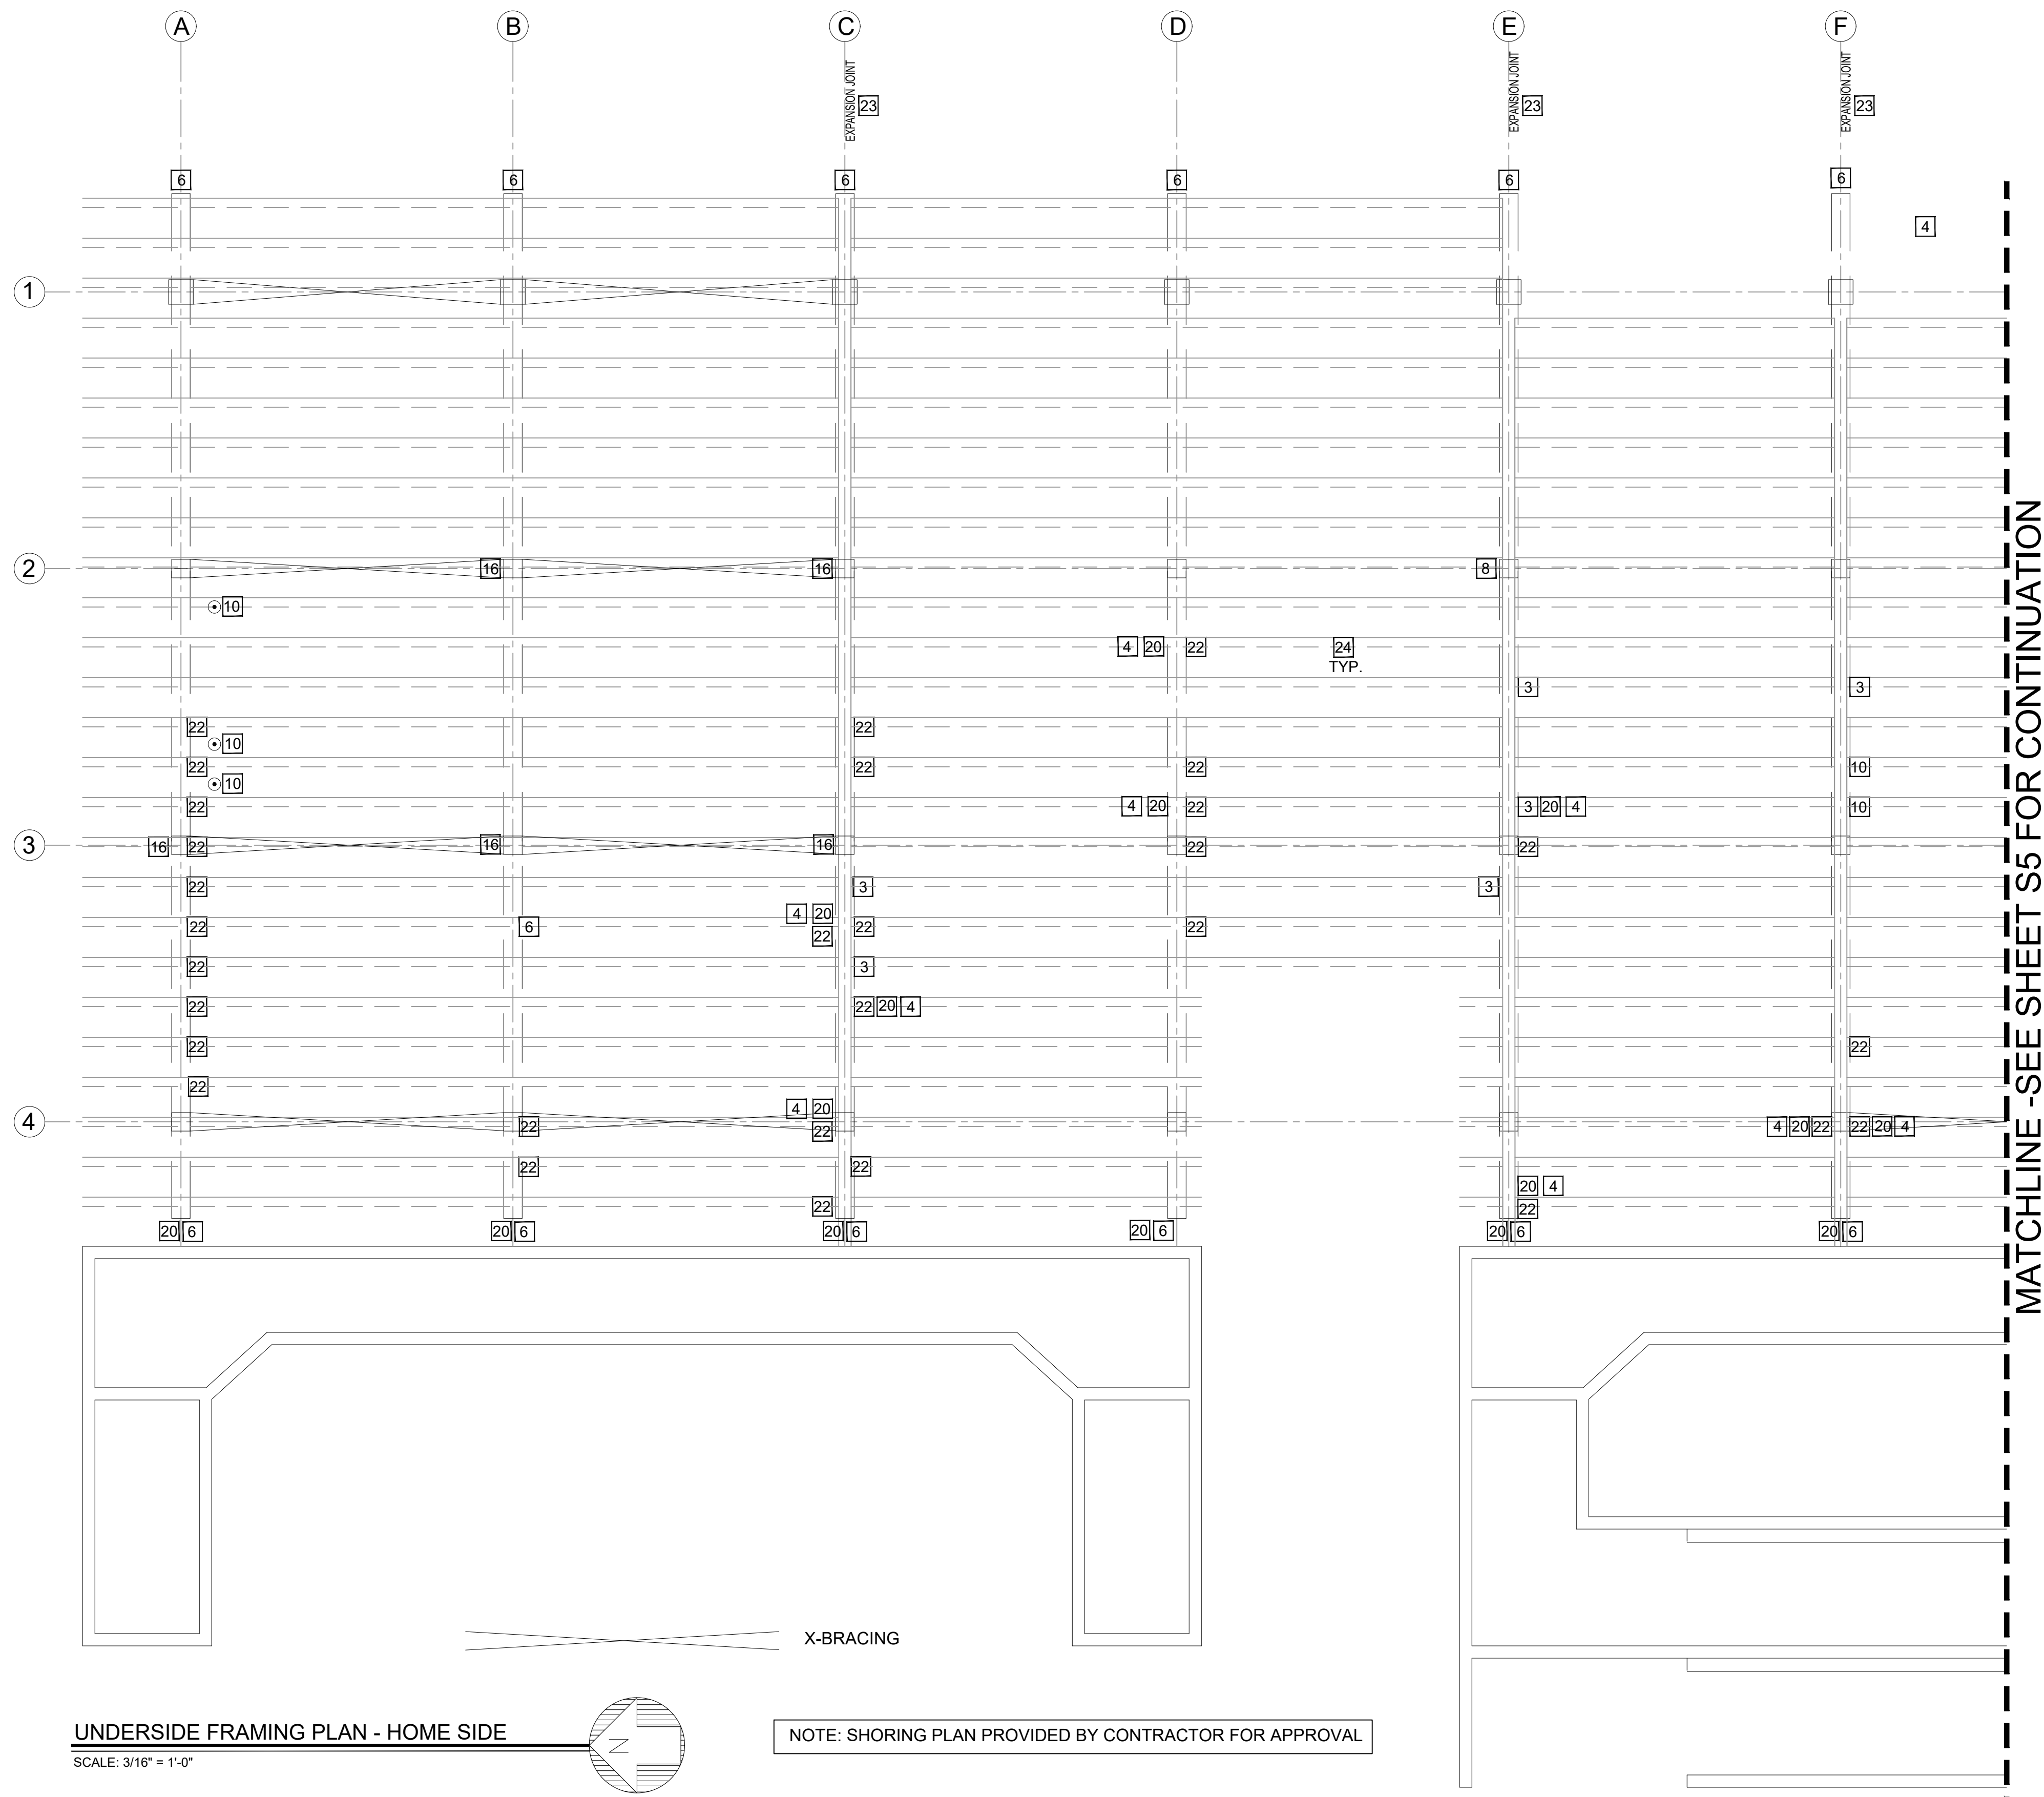
UNDERSIDE FRAMING PLAN - HOME SIDE
SCALE: 3/16" = 1'-0"

1	PARTIAL DEPTH REPAIR (S.F.)	8	S.F.
2	STUCCO WALL REPAIR (S.F.)	-	S.F.
3	EDGE REPAIR (L.F.)	17	L.F.
4	OVERHEAD REPAIRS (S.F.)	16	S.F.
5	CONCRETE COLUMN REPAIR (C.F.)	-	C.F.
6	CONCRETE GIRDER REPAIR (C.F.)	9	C.F.
7	GRAVITY FEED CRACK REPAIR (L.F.)	-	L.F.
8	WALL CRACK REPAIR (L.F.)	6	L.F.
9	FINISHES TO BE REMOVED & REPLACED (S.F.)	-	S.F.
10	RUST SPOT (EA.)	18	EA.
11	POST POCKET REPAIR (EA.)	-	EA.
12	STAIR TREADS REPAIR (S.F.)	-	S.F.
13	REMOVE & REPLACE GROUT UNDER STEP (S.F.)	-	S.F.
14	REMOVE & REPLACE WALL STUCCO TRIM (S.F.)	-	S.F.
15	REMOVE & REPLACE ANCHOR BOLTS (EA.)	-	EA.
16	REMOVE & REPLACE STEEL PLATE @ COLUMN (EA.)	7	EA.
17	REMOVE & REPLACE STEEL ANGLE SEAT - WELD RUST @ JOIST (EA.)	-	EA.
18	REPLACE CABLE X-BRACING (EA.)	-	EA.
19	REMOVE BY GRINDING OUT REBAR BOLSTER TIPS (EA.)	-	EA.
20	CLEAN REBAR (EA.)	15	EA.
21	SLAB CRACK INJECTIONS (L.F.)	-	L.F.
22	JOIST BEARING REPAIR (S.F.)	36	S.F.
23	EXPANSION JOINT REPAIR	200	L.F.

24	REMOVE & REPLACE BACKER ROD/SEALANT ALONG SEATING TREADRISER	2,548	L.F.

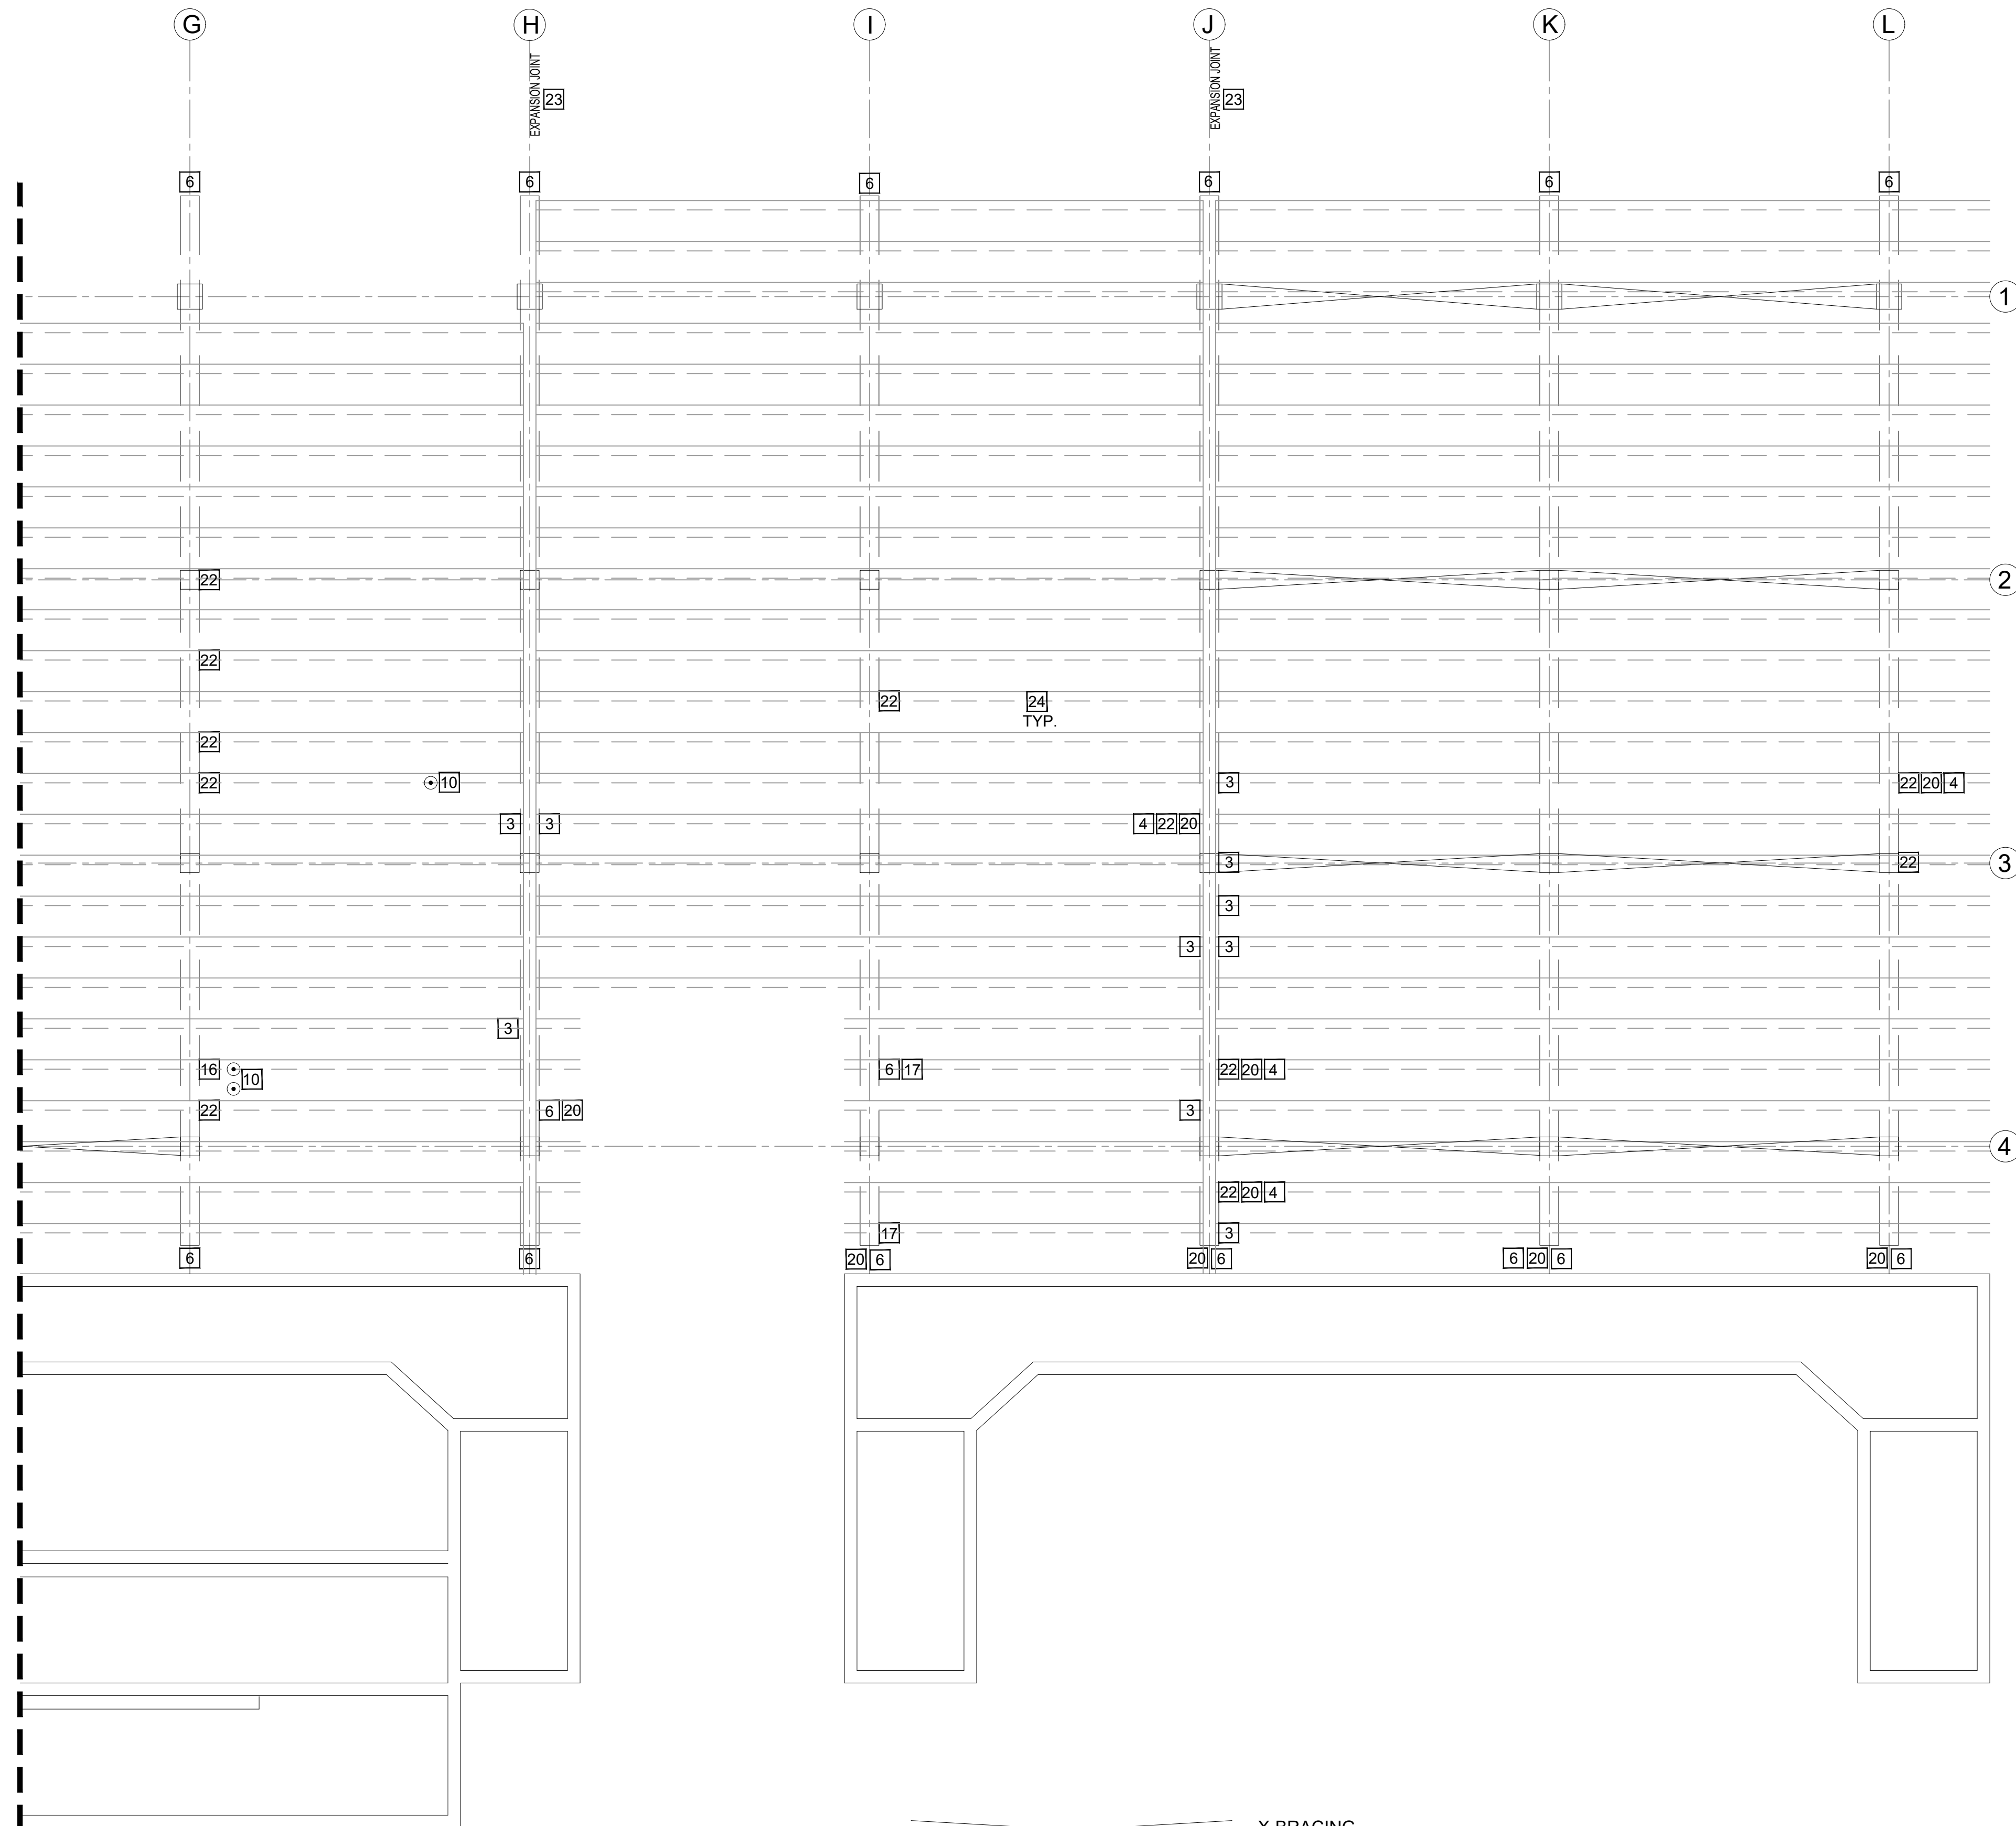
UNDERSIDE FRAMING PLAN - HOME SIDE
SCALE: 3/16" = 1'-0"

REPAIR LEGEND		
1	PARTIAL DEPTH REPAIR (S.F.)	3 S.F.
2	STUCCO WALL REPAIR (S.F.)	-- S.F.
3	EDGE REPAIR (L.F.)	28 L.F.
4	OVERHEAD REPAIRS (S.F.)	3 S.F.
5	CONCRETE COLUMN REPAIR (C.F.)	-- C.F.
6	CONCRETE GIRDER REPAIR (C.F.)	14 C.F.
7	GRAVITY FEED CRACK REPAIR (L.F.)	-- L.F.
8	WALL CRACK REPAIR (L.F.)	-- L.F.
9	FINISHES TO BE REMOVED & REPLACED (S.F.)	-- S.F.
10	RUST SPOT (EA.)	15 EA.
11	POST POCKET REPAIR (EA.)	-- EA.
12	STAIR TREADS REPAIR (S.F.)	-- S.F.
13	REMOVE & REPLACE GROUT UNDER STEP (S.F.)	-- S.F.
14	REMOVE & REPLACE WALL STUCCO TRIM (S.F.)	-- S.F.
15	REMOVE & REPLACE ANCHOR BOLTS (EA.)	-- EA.
16	REMOVE & REPLACE STEEL PLATE @ COLUMN (EA.)	1 EA.
17	REMOVE & REPLACE STEEL ANGLE SEAT - WELD RUST @ JOIST (EA.)	2 EA.
18	REPLACE CABLE X-BRACING (EA.)	-- EA.
19	REMOVE BY GRINDING OUT REBAR BOLSTER TIPS (EA.)	-- EA.
20	CLEAN REBAR (EA.)	10 EA.
21	SLAB CRACK INJECTIONS (L.F.)	-- L.F.
22	JOIST BEARING REPAIR (S.F.)	4 S.F.

23	EXPANSION JOINT REPAIR	138 L.F.
24	REMOVE & REPLACE BACKER ROOSEALANT ALONG SEATING TREADRISER	2,548 L.F.

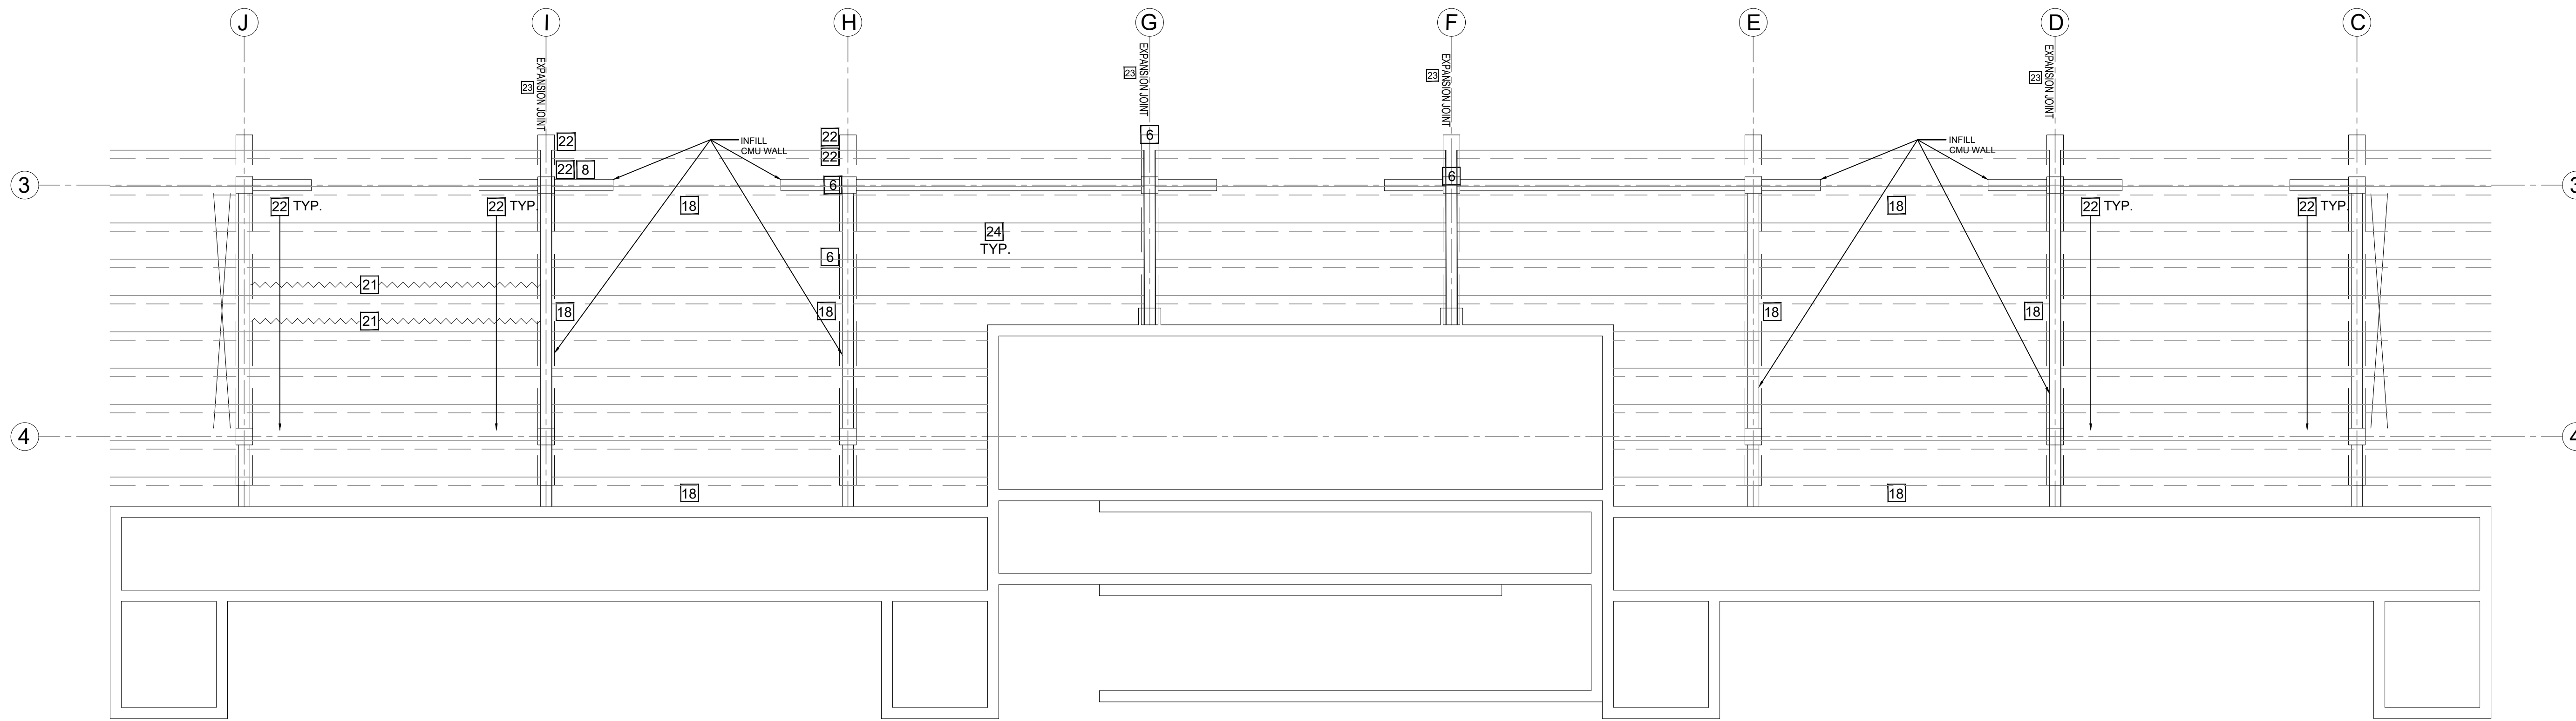
UNDERSIDE FRAMING PLAN - VISITOR SIDE  
SCALE: 3/16" = 1'-0"

| REPAIR LEGEND | | |
|---|---|---|
| 3 | EDGE REPAIR (L.F.) | 44 L.F. |
| 6 | CONCRETE GIRDER REPAIR (C.F.) | 11 C.F. |
| 8 | WALL CRACK REPAIR (L.F.) | 8 L.F. |
| 18 | REPLACE CABLE X-BRACING (EA) | 9 EA |
| 21 | SLAB CRACK INJECTIONS (L.F.) | 44 L.F. |
| 22 | JOIST BEARING REPAIR (S.F.) | 8 S.F. |
| 23 | EXPANSION JOINT REPAIR | 81 L.F. |
| 24 | REMOVE & REPLACE BACKER ROD/SEALANT ALONG SEATING TREAD/RISER | 1284 L.F. |
