STRUCTURAL-GENERAL NOTES

LIFE SAFETY REPAIR PLAN

SEBASTIAN RIVER HIGH SCHOOL
 Stadium Inspection
 9001 Shark Boulevard
 SEBASTIAN, FLORIDA

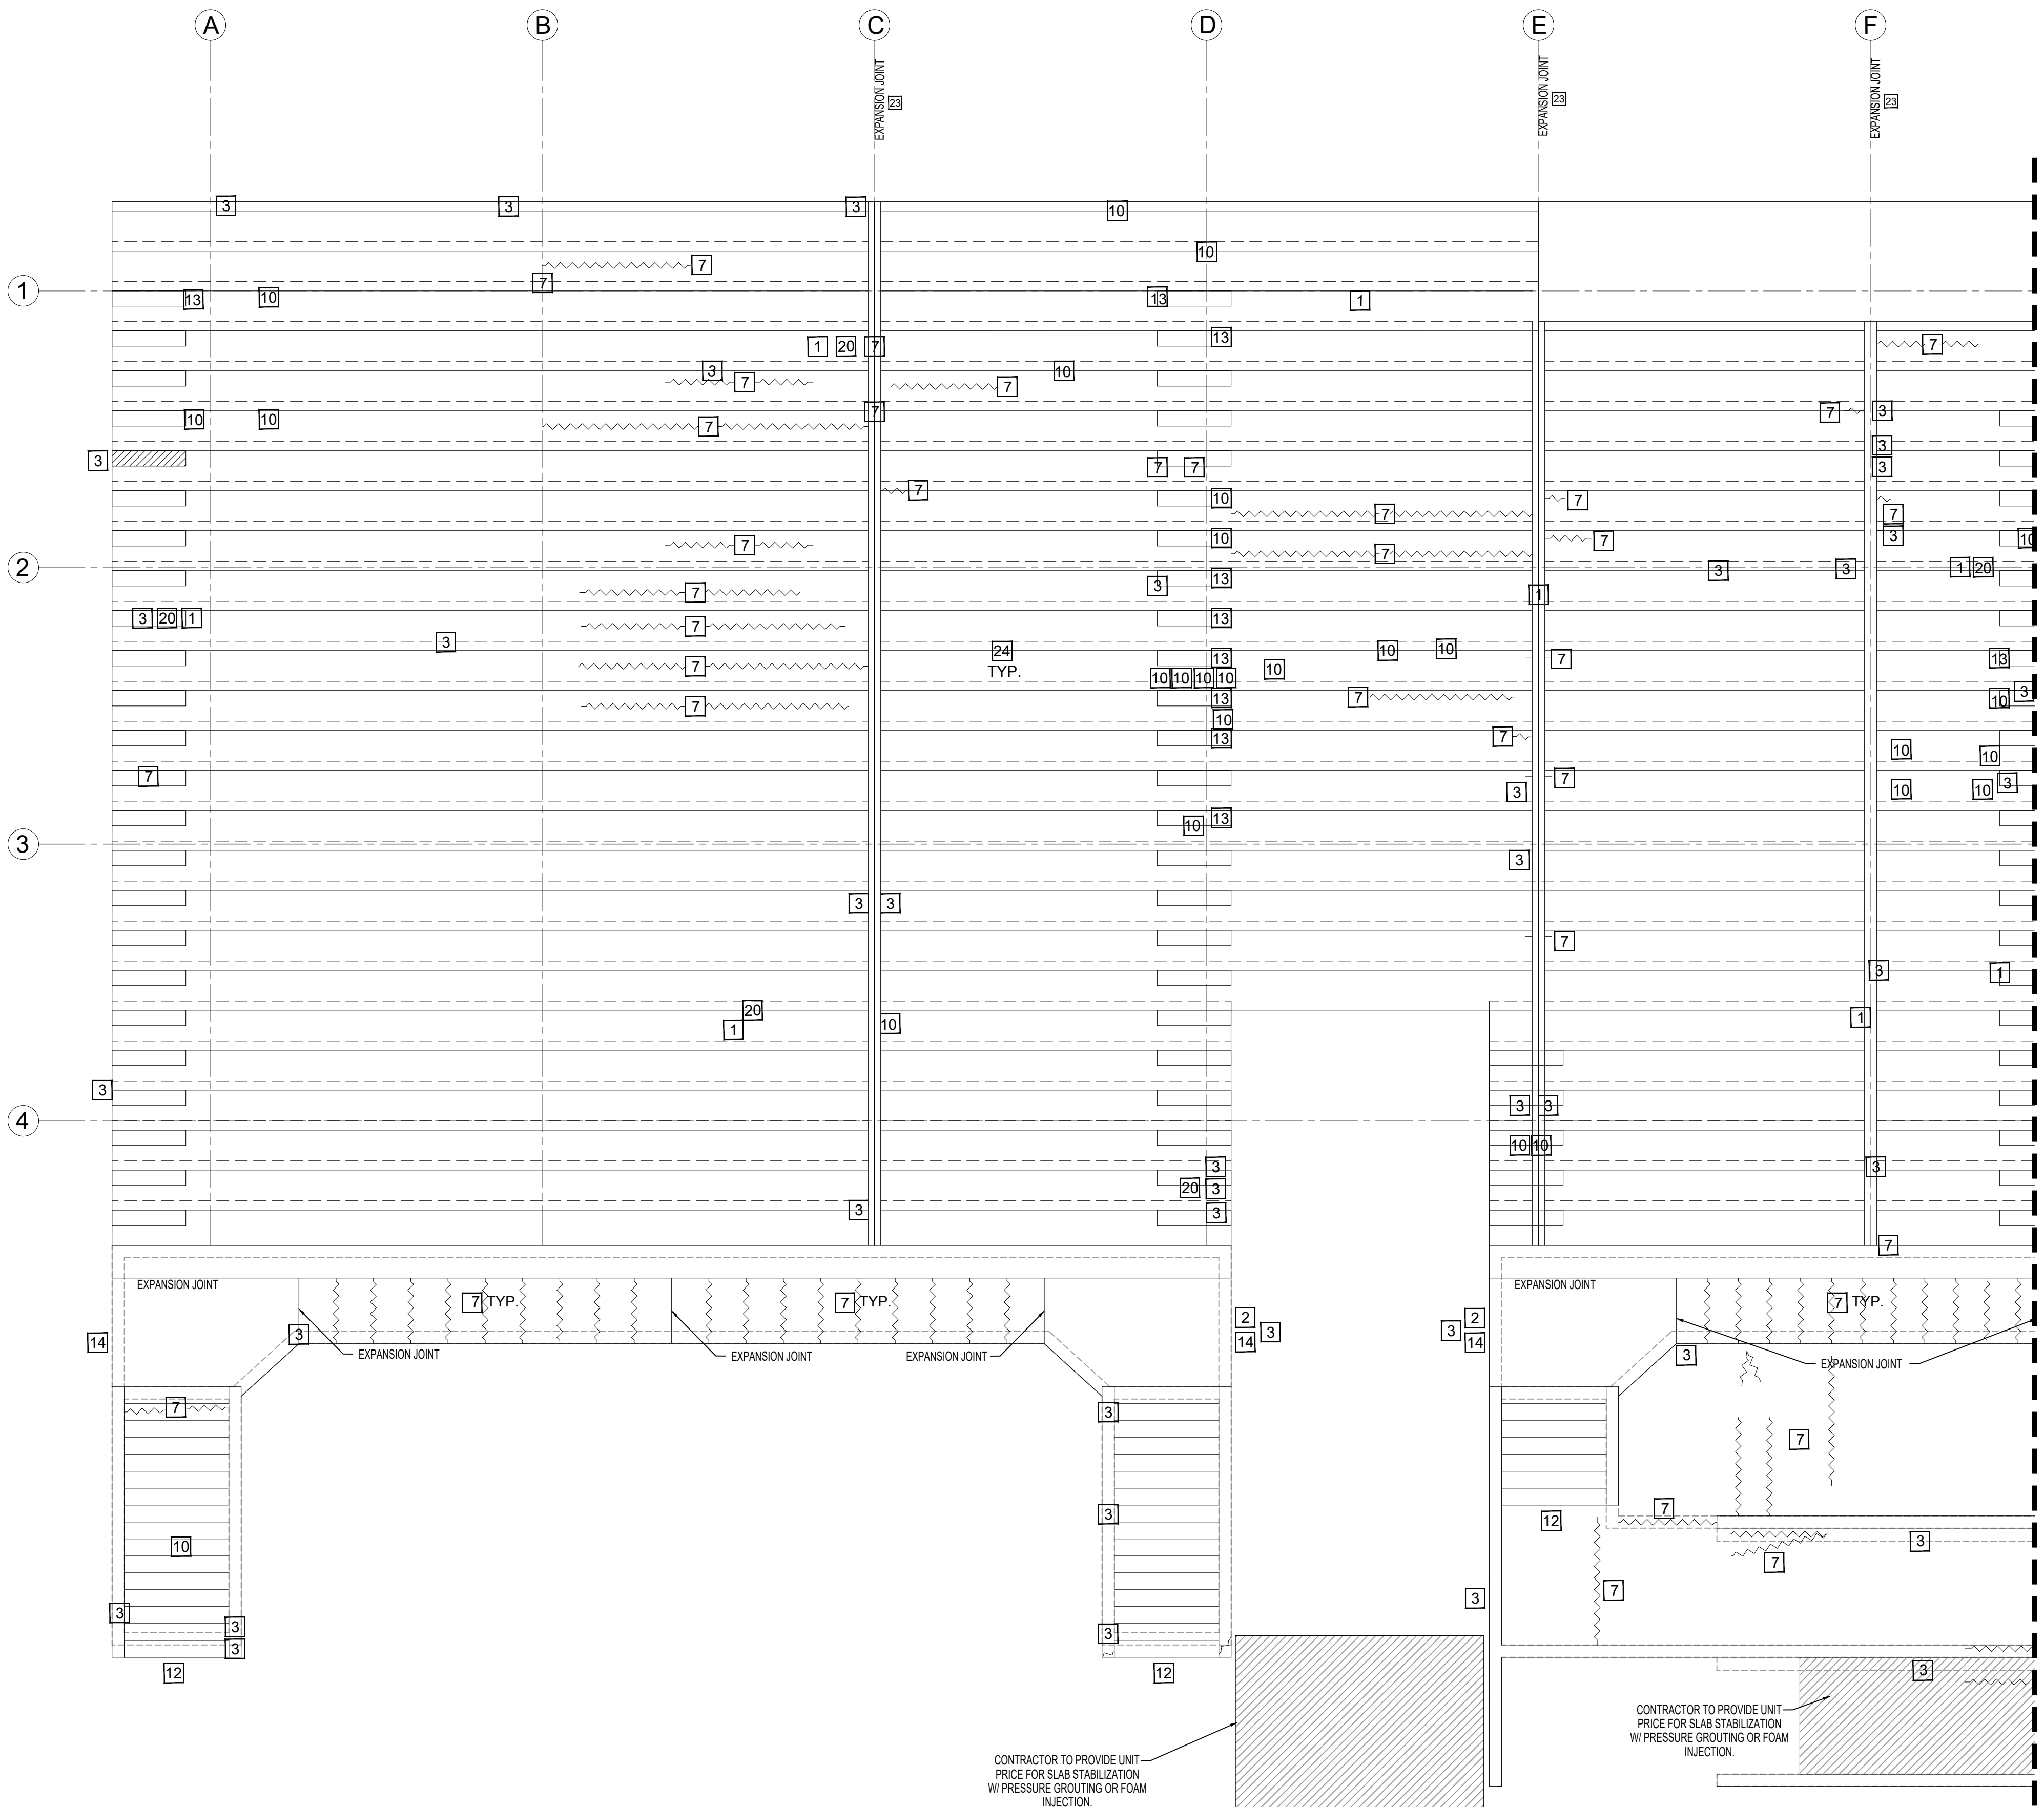
| REPAIR LEGEND | | |
|---|--|---|
| 2 | STUCCO WALL REPAIR (S.F.) | 183 S.F. |
| 3 | EDGE REPAIR (L.F.) | 183 L.F. |
| 7 | GRAVITY FEED CRACK REPAIR (L.F.) | 371 L.F. |
| 10 | RUST SPOT (EA) | 28 EA |
| 12 | STAIR TREADS REPAIR (S.F.) | 20 S.F. |
| 13 | REMOVE & REPLACE GROUT UNDER STEP (S.F.) | 41 S.F. |
| 14 | REMOVE & REPLACE WALL STUCCO TRIM (S.F.) | 15 S.F. |
| 23 | EXPANSION JOINT REPAIR | 196 L.F. |
| 24 | REMOVE & REPLACE BACKER ROD/SEALANT ALONG SEATING TREADRISER | 1,018 L.F. |

ALL EXPANSION JOINTS ARE BAD.
ALL EXPANSION JOINTS SHALL BE REPLACED.

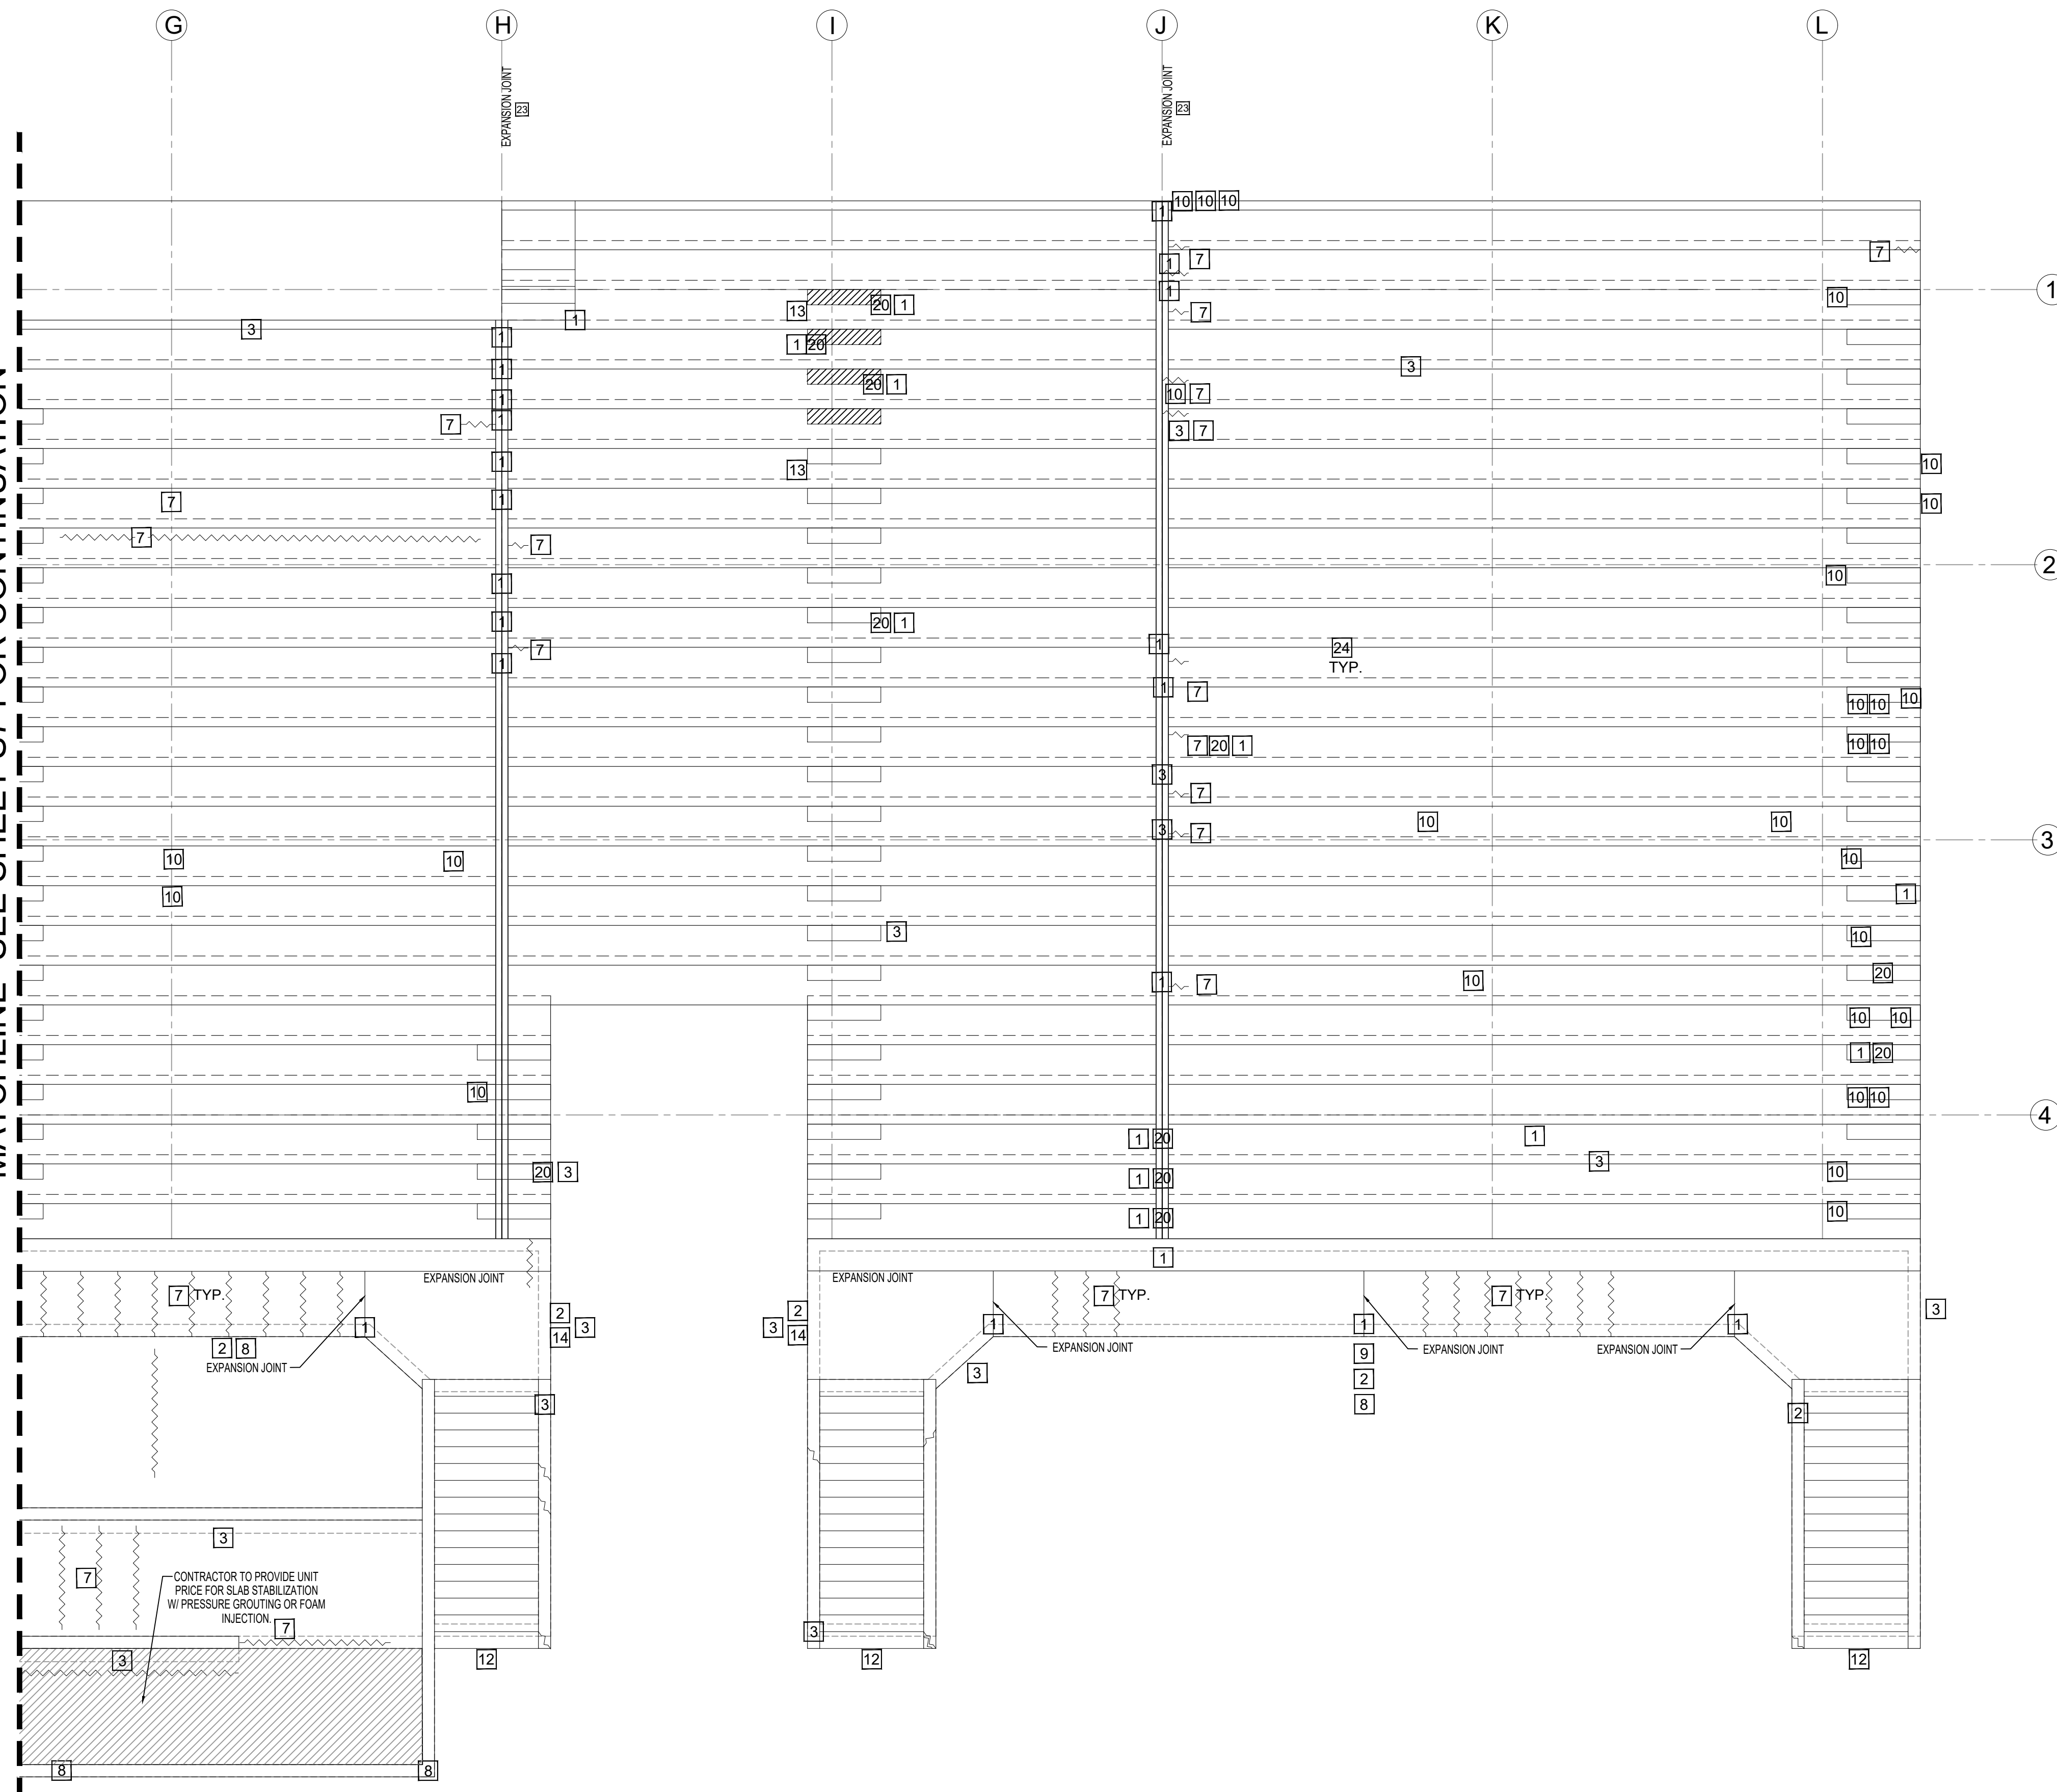
PLAN VIEW - HOME SIDE
SCALE: 3/16" = 1'-0"

ALL EXPANSION JOINTS ARE BAD.
ALL EXPANSION JOINTS
SHALL BE REPLACED.

| REPAIR LEGEND | | |
|---|---|---|
| 1 | PARTIAL DEPTH REPAIR (S.F.) | 11 S.F. |
| 2 | STUCCO WALL REPAIR (S.F.) | 121 S.F. |
| 3 | EDGE REPAIR (L.F.) | 100 L.F. |
| 7 | GRAVITY FEED CRACK REPAIR (L.F.) | 206 L.F. |
| 8 | WALL CRACK REPAIR (L.F.) | 21 L.F. |
| 10 | RUST SPOT (EA.) | 29 EA. |
| 12 | STAIR TREADS REPAIR (S.F.) | 20 S.F. |
| 13 | REMOVE & REPLACE GROUT UNDER STEP (S.F.) | 9 S.F. |
| 14 | REMOVE & REPLACE WALL STUCCO TRIM (S.F.) | 20 S.F. |
| 23 | EXPANSION JOINT REPAIR | 128 L.F. |
| --- | LOOSE STEP | 4 EA. |
