STRUCTURAL-GENERAL NOTES

LIFE SAFETY REPAIR PLAN

SEBASTIAN RIVER HIGH SCHOOL
 Stadium Inspection
 9001 Shark Boulevard
 SEBASTIAN, FLORIDA

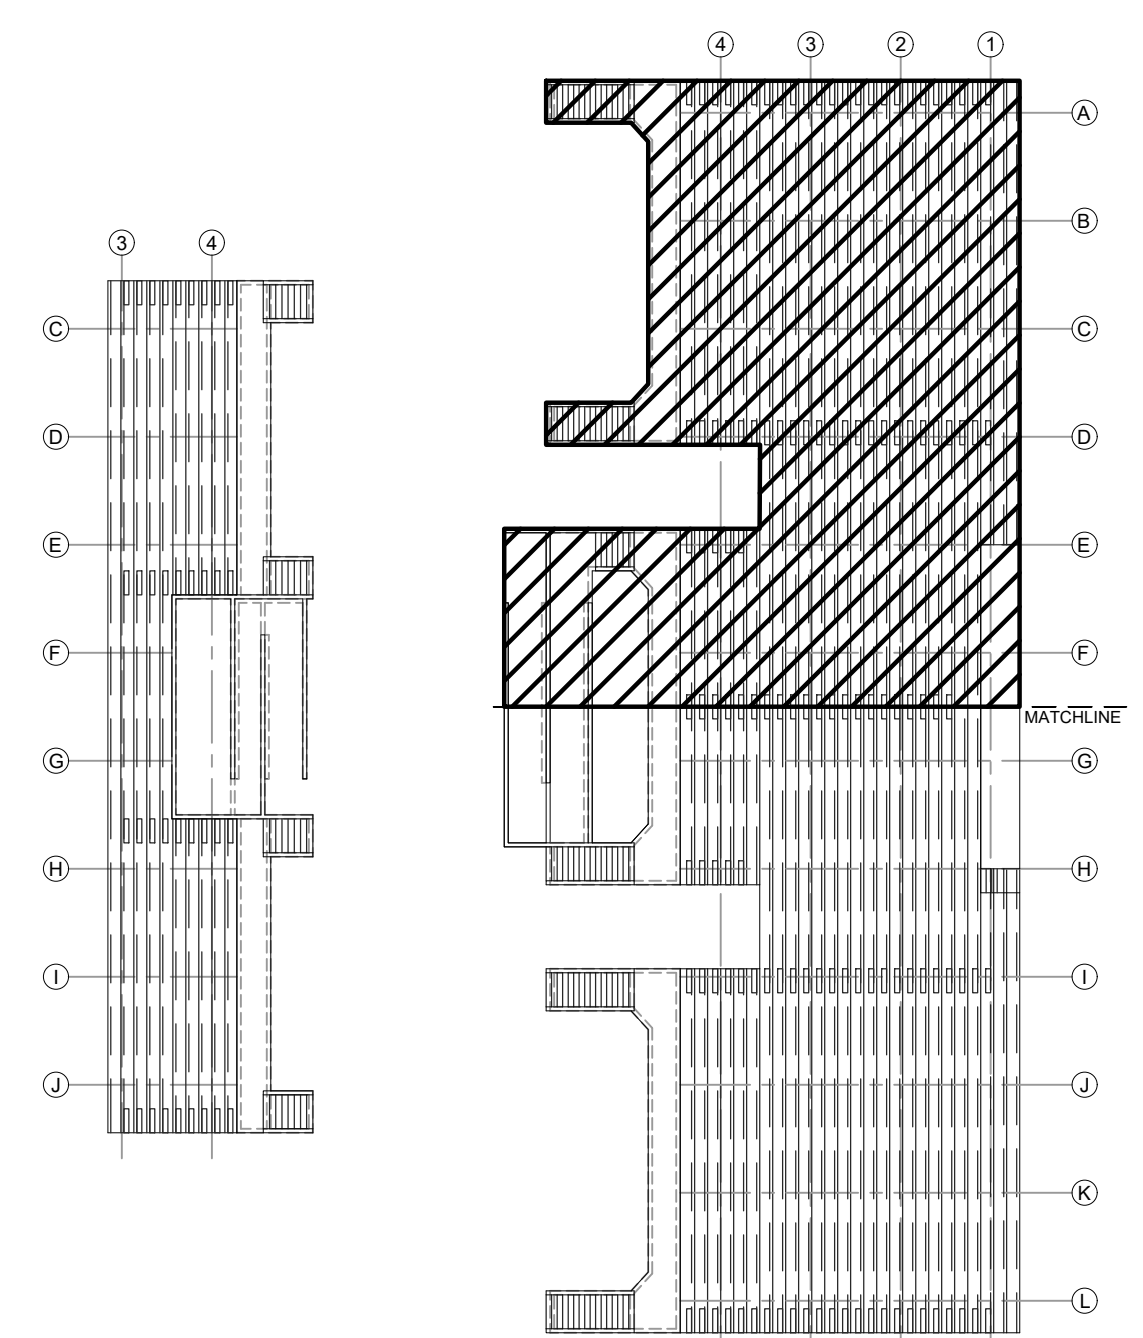
1	REPAIR BRACKET TO SEAT CONNECTION (EA)	5	EA
2	REPAIR BOTTOM TO CONCRETE CONNECTION (EA)	3	EA
3	REPLACE CHAIN LINK CLIPS (EA)	2	EA
4	FENCE CHAIN LINK EXTENSION (ADDDREPAIR) (L.F.)	4	L.F.
5	REMOVE & REPLACE FENCE (L.F.)	-	L.F.
6	REMOVE & REPLACE GUARDRAIL (L.F.)	-	L.F.
7	REMOVE & REPLACE HANDRAIL (L.F.)	55	L.F.
8	REPLACE MISSING SEAT SEAM FASTENERS (EA)	-	EA
9	REMOVE ABANDONED POST (EA)	4	EA

(#) #
 INDICATES THE LOCATIONS OF CONNECTION FROM LEFT TO RIGHT
 INDICATES THE NUMBER OF CONNECTORS MISSING

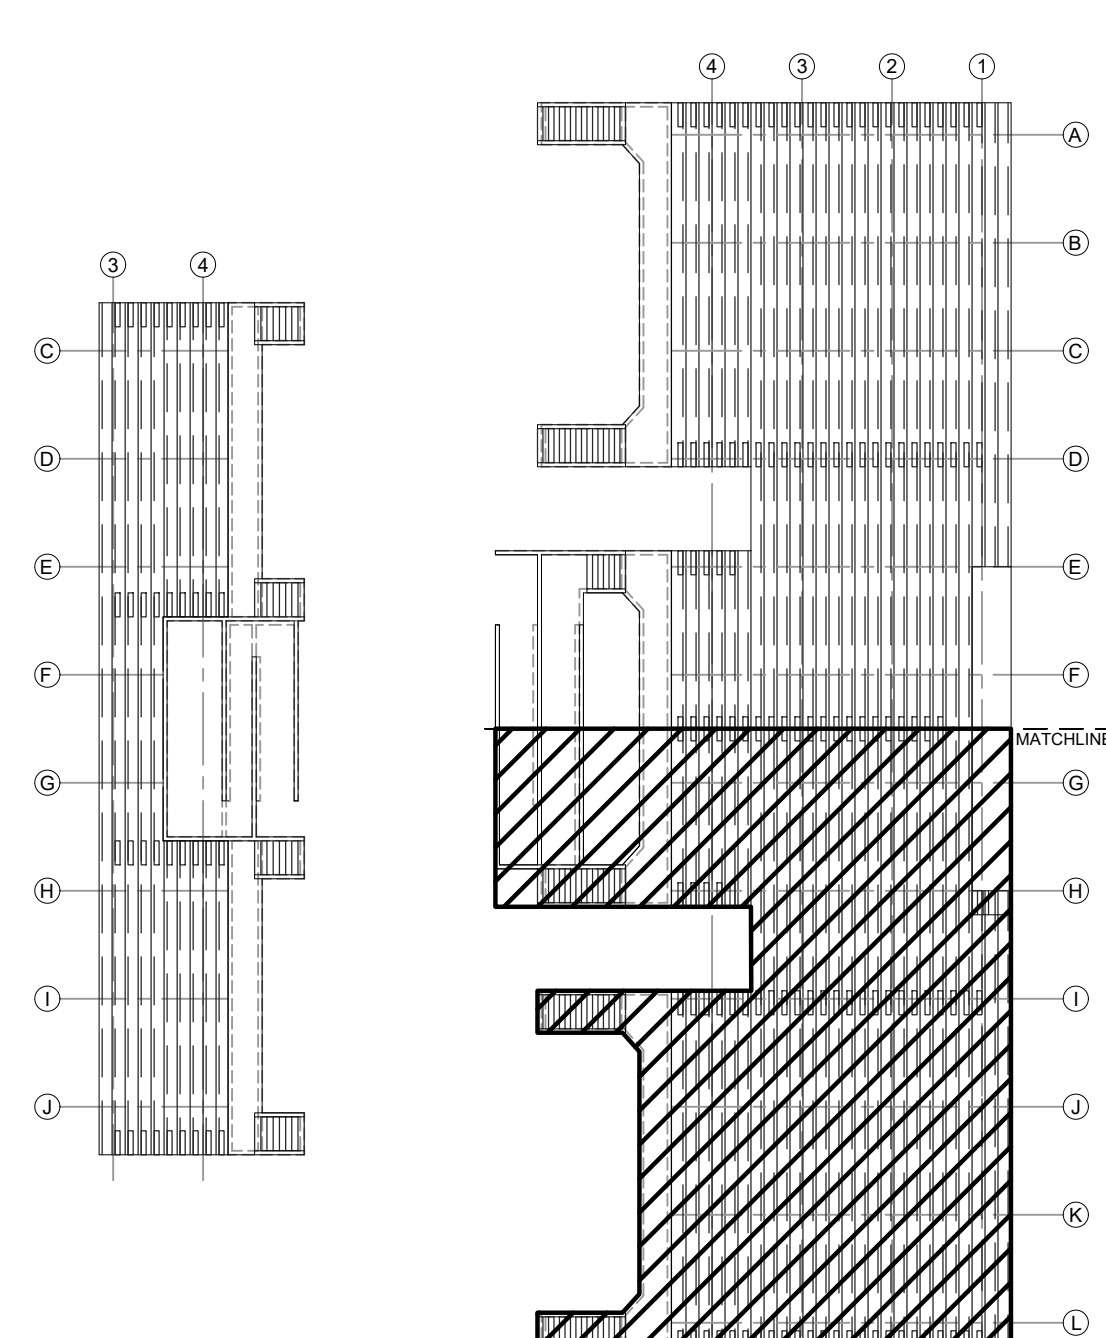
LIFE SAFETY REPAIRS LEGEND			
1	REPAIR BRACKET TO SEAT CONNECTION (EA)	1	EA
2	REPAIR BOTTOM TO CONCRETE CONNECTION (EA)	3	EA
3	REPLACE CHAIN LINK CLIPS (EA)	10	EA
4	FENCE CHAIN LINK EXTENSION (ADD/REPAIR) (L.F.)	7	L.F.
5	REMOVE & REPLACE FENCE (L.F.)	-	L.F.
6	REMOVE & REPLACE GUARDRAIL (L.F.)	10	L.F.
7	REMOVE & REPLACE HANDRAIL (L.F.)	27	L.F.
8	REPLACE MISSING SEAT SEAM FASTENERS (EA)	1	EA
9	REMOVE POST (EA)	4	EA

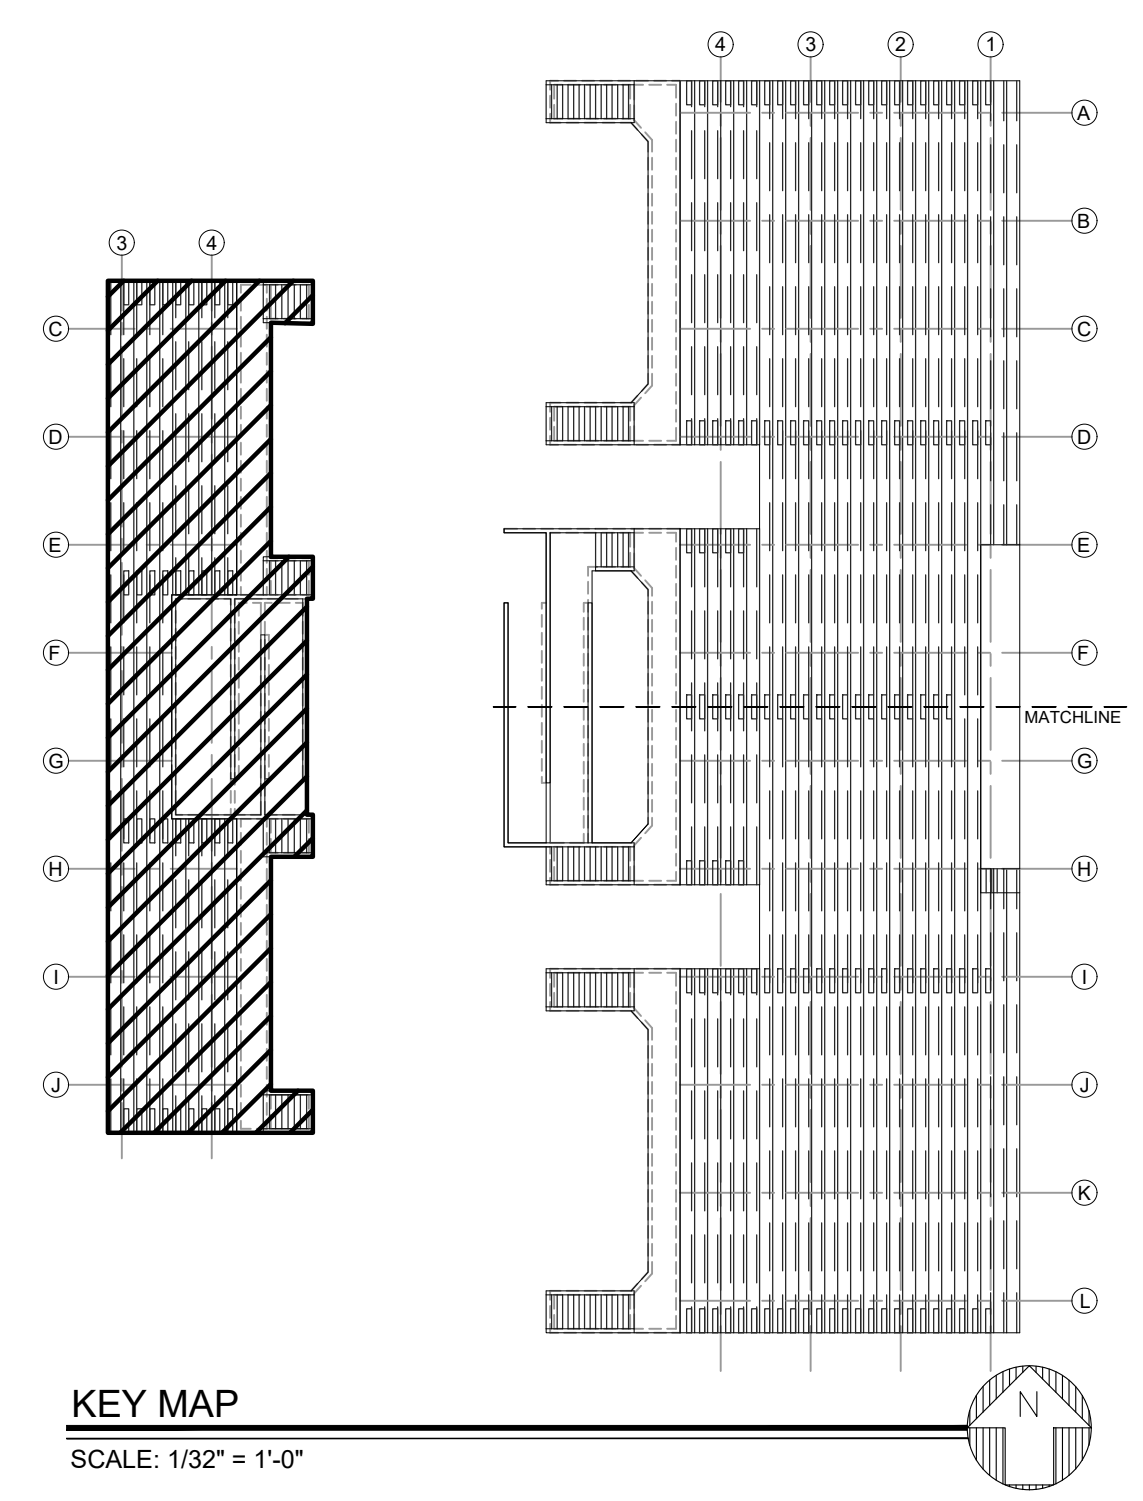
LIFE SAFETY REPAIR PLAN

LIFE SAFETY REPAIRS LEGEND		
1	REPAIR BRACKET TO SEAT CONNECTION (EA)	4 EA.
2	REPAIR BOTTOM TO CONCRETE CONNECTION (EA)	5 EA.
3	REPLACE CHAIN LINK CLIPS (EA)	- EA.
4	FENCE CHAIN LINK EXTENSION (ADD/REPAIR) (L.F.)	4 L.F.
5	REMOVE & REPLACE FENCE (L.F.)	109 L.F.
6	REMOVE & REPLACE GUARDRAIL (L.F.)	- L.F.
7	REMOVE & REPLACE HANDRAIL (L.F.)	- L.F.
8	REPLACE MISSING SEAT SEAM FASTENERS (EA)	- EA.
9	REMOVE POST (EA)	- EA.

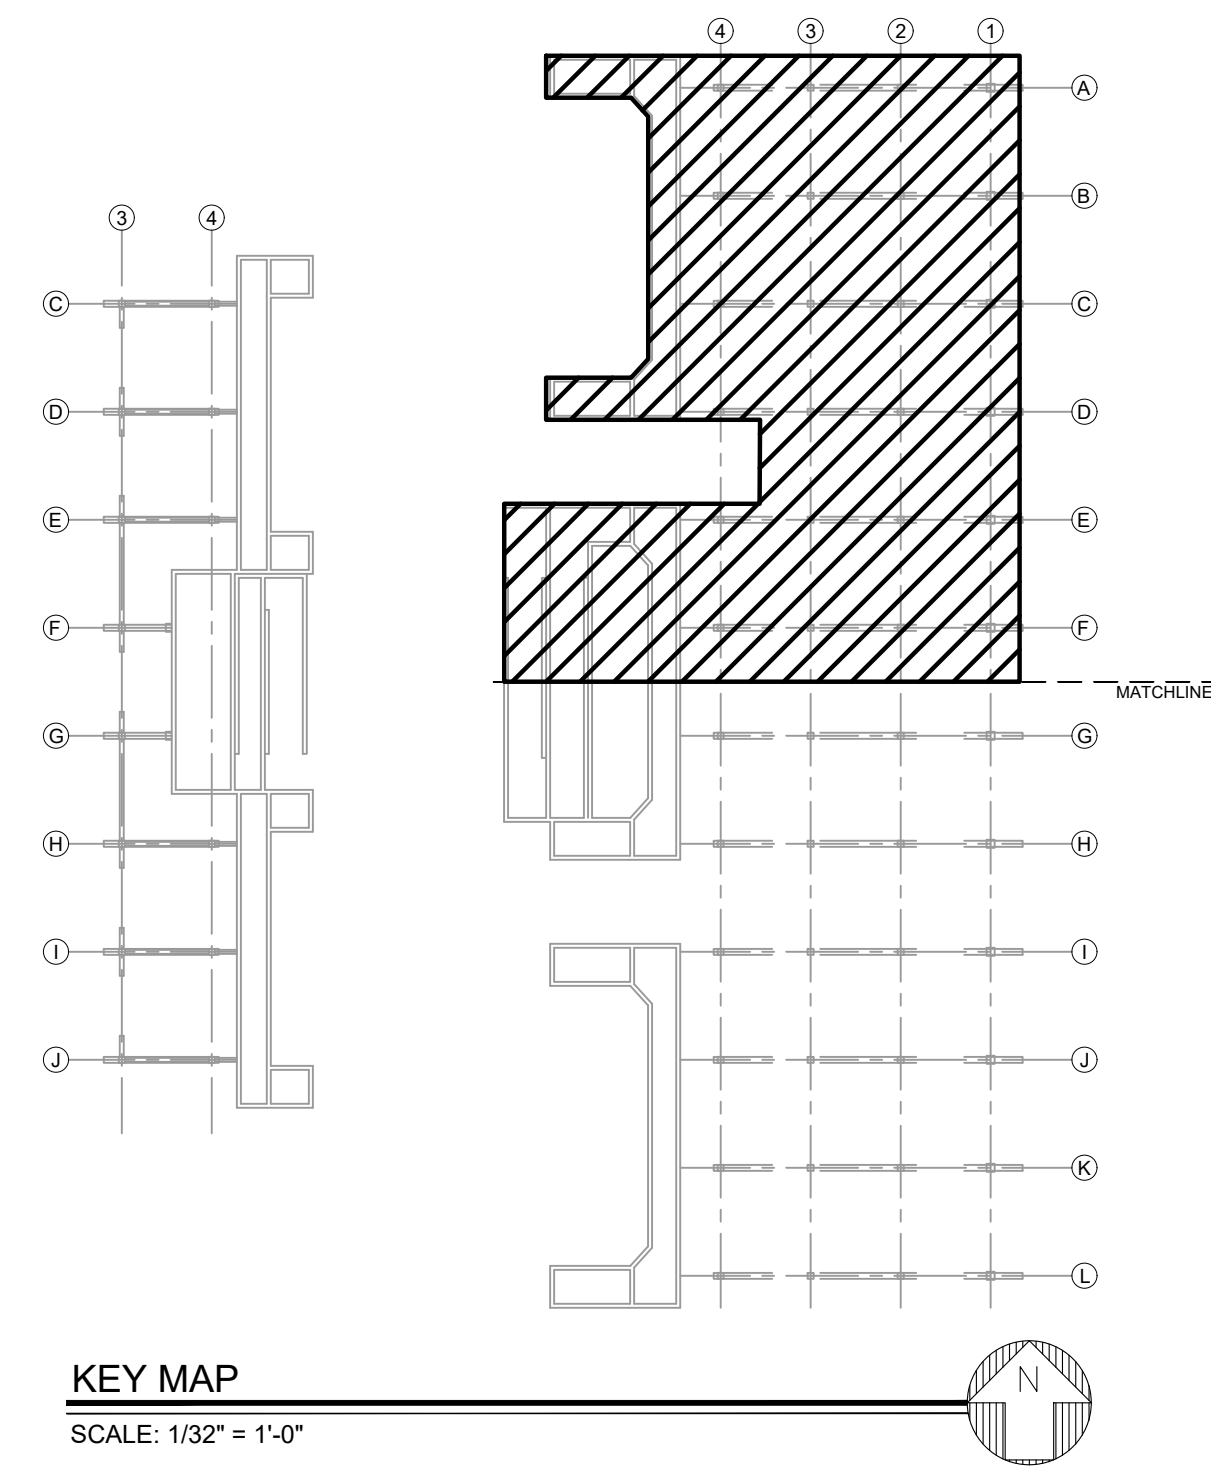
UNDERSIDE FRAMING PLAN - HOME SIDE
SCALE: 3/16" = 1'-0"

1	PARTIAL DEPTH REPAIR (S.F.)	8	S.F.
2	STUCCO WALL REPAIR (S.F.)	-	S.F.
3	EDGE REPAIR (L.F.)	17	L.F.
4	OVERHEAD REPAIRS (S.F.)	16	S.F.
5	CONCRETE COLUMN REPAIR (C.F.)	-	C.F.
6	CONCRETE GIRDER REPAIR (C.F.)	9	C.F.
7	GRAVITY FEED CRACK REPAIR (L.F.)	-	L.F.
8	WALL CRACK REPAIR (L.F.)	6	L.F.
9	FINISHES TO BE REMOVED & REPLACED (S.F.)	-	S.F.
10	RUST SPOT (EA.)	18	EA.
11	POST POCKET REPAIR (EA.)	-	EA.
12	STAIR TREADS REPAIR (S.F.)	-	S.F.
13	REMOVE & REPLACE GROUT UNDER STEP (S.F.)	-	S.F.
14	REMOVE & REPLACE WALL STUCCO TRIM (S.F.)	-	S.F.
15	REMOVE & REPLACE ANCHOR BOLTS (EA.)	-	EA.
16	REMOVE & REPLACE STEEL PLATE @ COLUMN (EA.)	7	EA.
17	REMOVE & REPLACE STEEL ANGLE SEAT - WELD RUST @ JOIST (EA.)	-	EA.
18	REPLACE CABLE X-BRACING (EA.)	-	EA.
19	REMOVE BY GRINDING OUT REBAR BOLSTER TIPS (EA.)	-	EA.
20	CLEAN REBAR (EA.)	15	EA.
21	SLAB CRACK INJECTIONS (L.F.)	-	L.F.
22	JOIST BEARING REPAIR (S.F.)	36	S.F.
23	EXPANSION JOINT REPAIR	200	L.F.

24	REMOVE & REPLACE BACKER ROD/SEALANT ALONG SEATING TREADRISER	2,548	L.F.

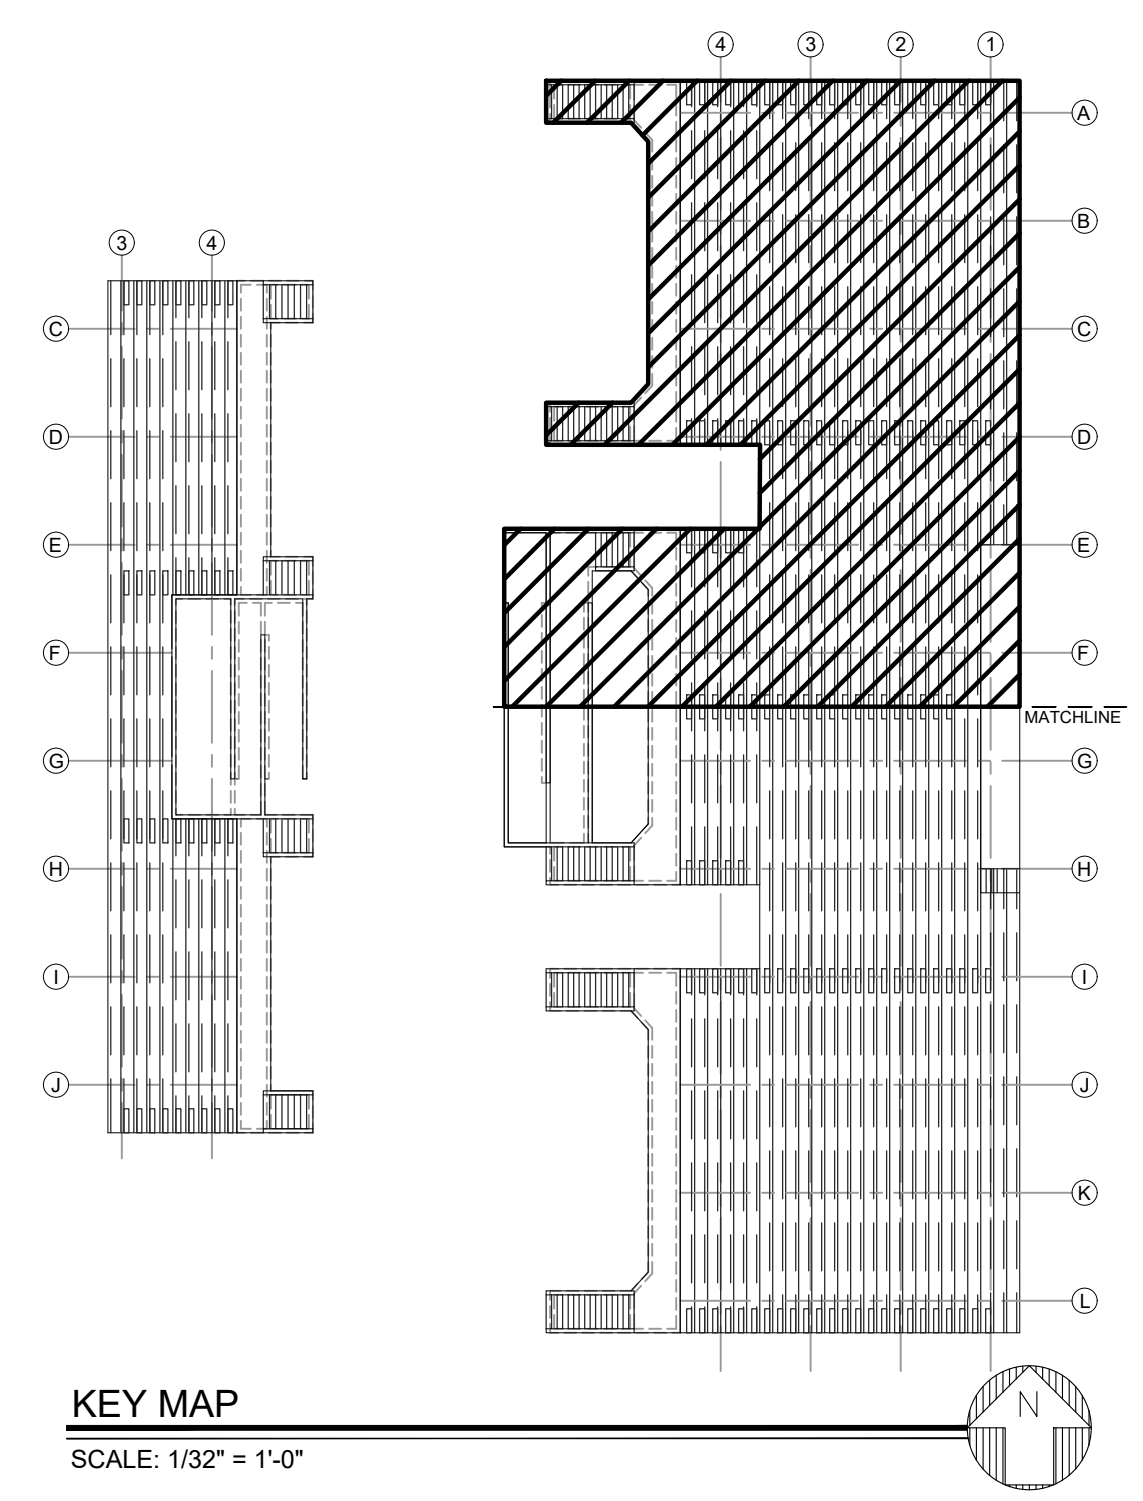
REPAIRS TO STRUCTURE
VIEW FROM UPPER LEVEL

ALL EXPANSION JOINTS ARE BAD.
ALL EXPANSION JOINTS SHALL BE REPLACED.

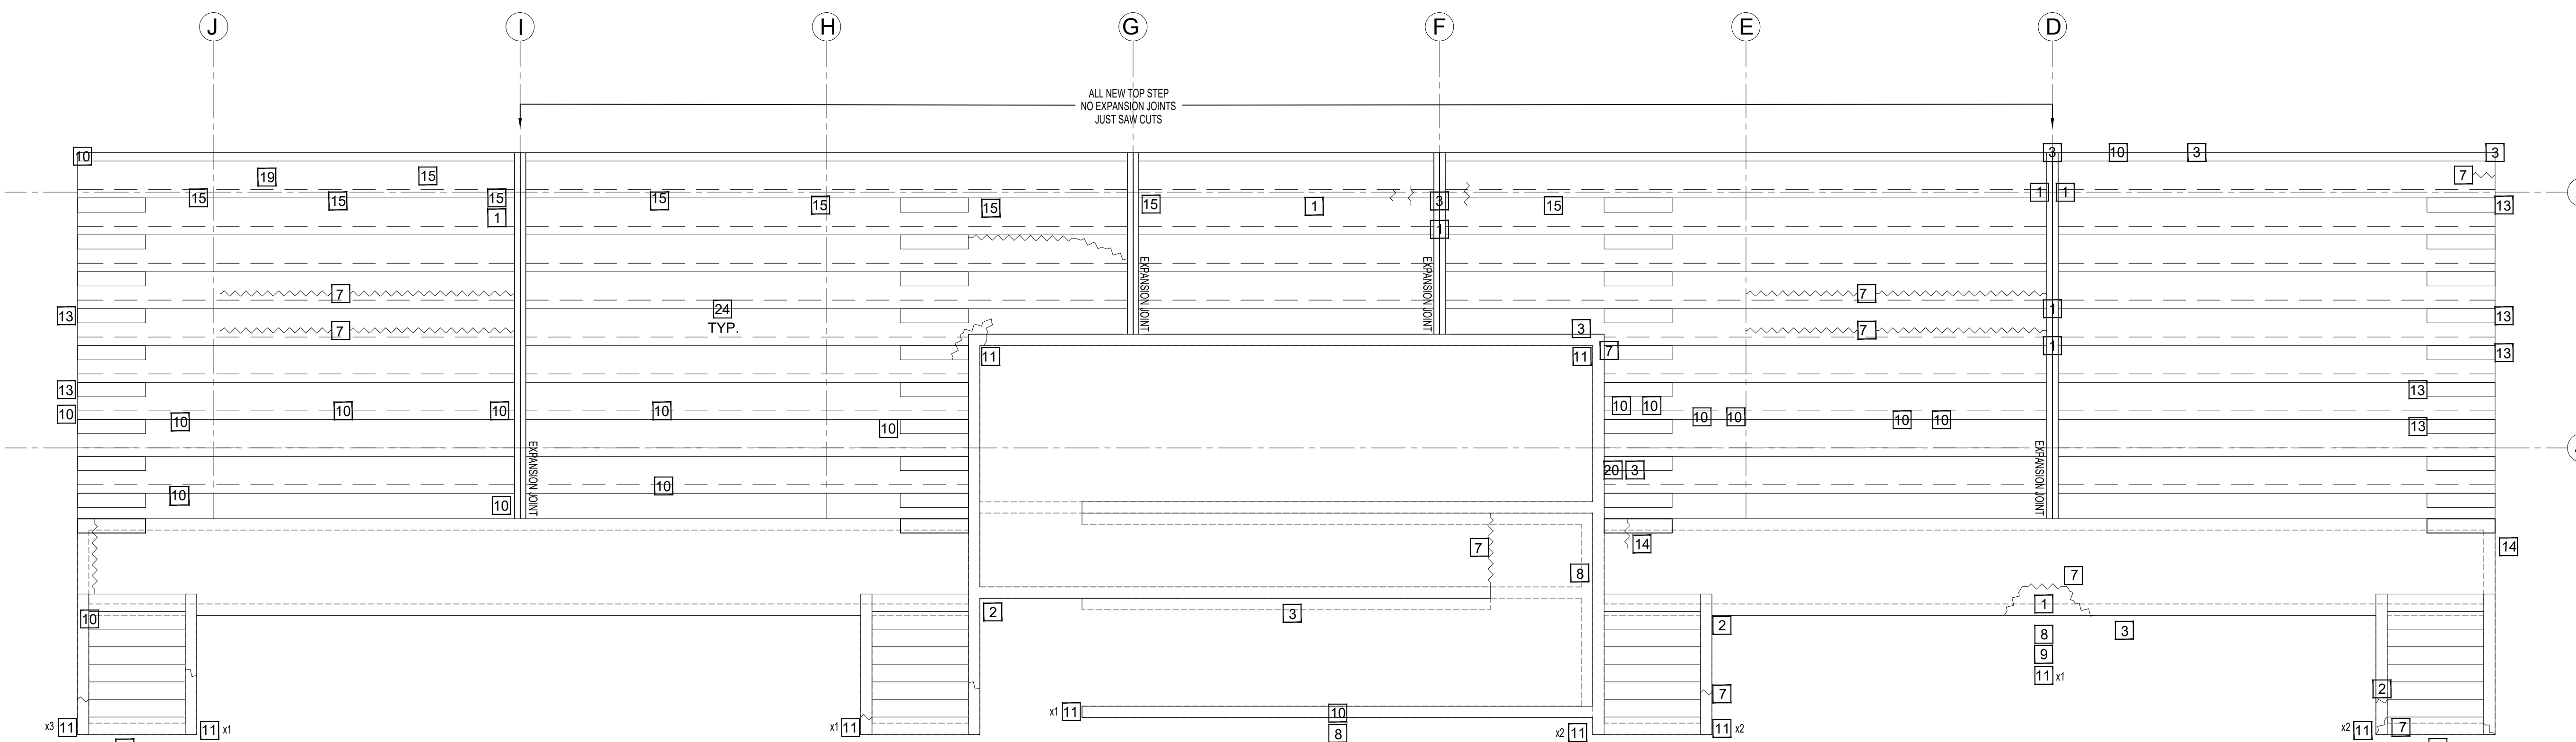
PLAN VIEW - VISITOR SIDE
SCALE: 3/16" = 1'-0"

ALL EXPANSION JOINTS ARE BAD.
ALL EXPANSION JOINTS SHALL BE REPLACED.
